MEMORANDUM

2057 S 59th Street Sanitary Lateral Repair in street

DATE: 4/13/2020

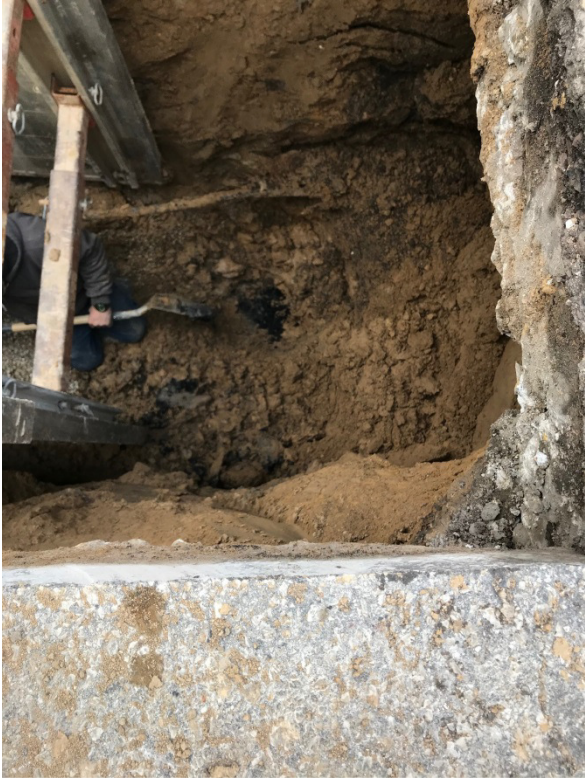
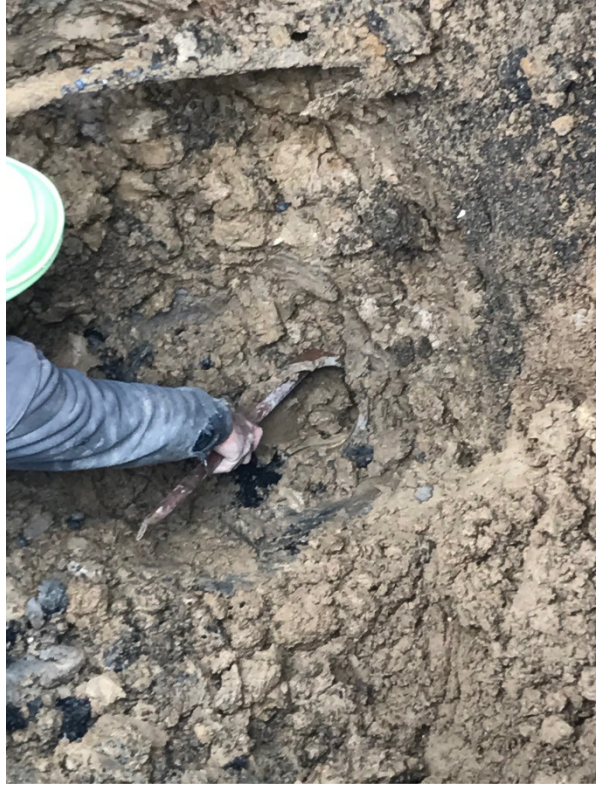
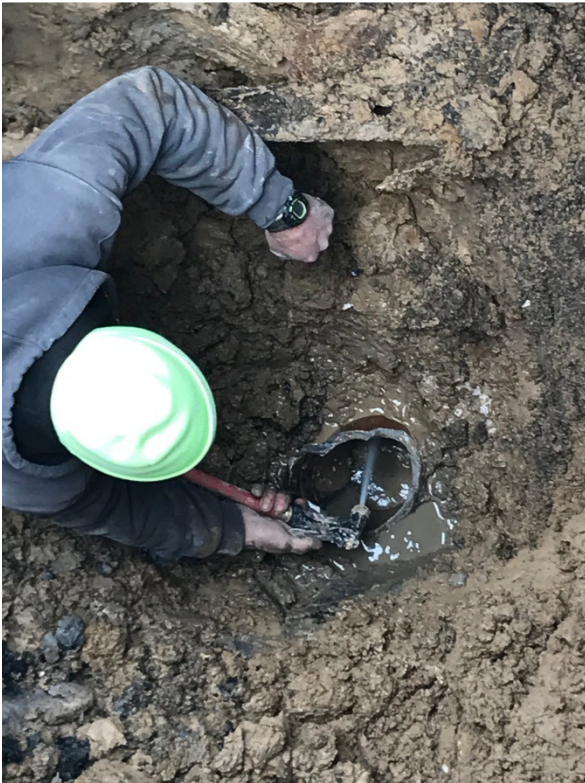
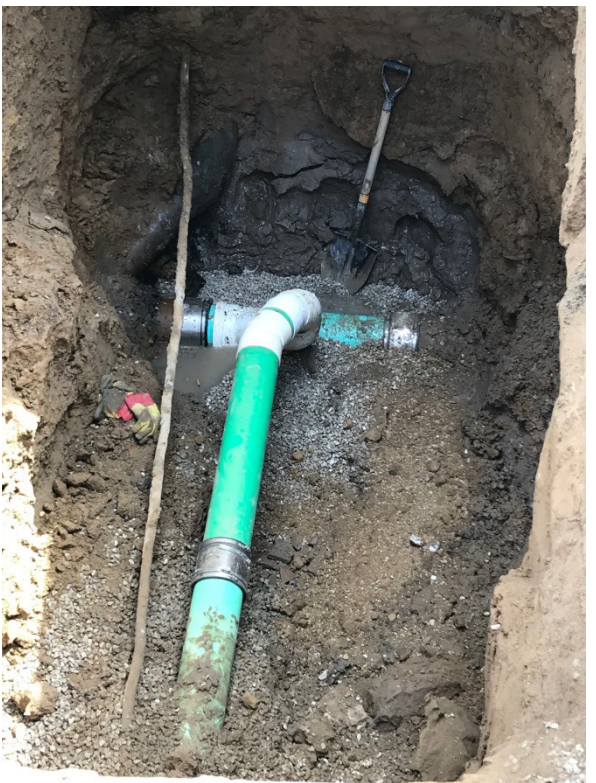
Sanitary lateral blockage causing backups in basement. Resident verbally told me that they have been having backups for months. It took this long to come up with a down payment for plumber.

Lateral is crumbling away as it's exposed.

Wye connection requires replacement due to failing condition.

I watched the lateral crumble away all the way to the sanitary main as the contractor hand dug, once exposed.

Because of the failing lateral, the surrounding soil may be the cause of the fail at the wye connection.

I would conclude that due to the failing 6" clay lateral, the City may be liable for a portion near the main at the wye connection.

Gene Wagner repairs 8" wye connection on sanitary main from 1919 & 12 – 14' of 6" clay lateral originally installed in 1921 (2 man crew).

Contractor replaces wye connection at the sanitary main along with 6" PVC to existing lateral.

Slurry backfill.

Permanent concrete restoration performed.
