### City of West Allis Matter Summary

Communication from City Engineer regarding payment of sanitary sewer lateral repair claims at

Failure of City of West Allis Sanitary Sewer at 1505 S. 74 St.

RE: Failure of City of West Allis Sanitary Sewer at 1533 S. 74 Street

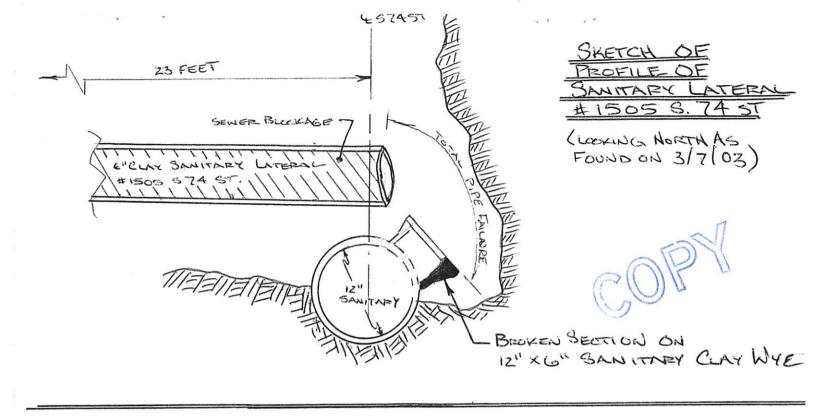
Gene Wagner Plumbing had the road excavated at the sanitary main at the wye for 1504 S. 74 St. I saw the 6 in. lateral (east-west) lying above the 12 in. main just south of the wye connection (facing east??) The wye connection was measured at 66 ft. south of the existing sanitary manhole. The depth of the 12 in. wye is 10.1 ft. down from the existing grade of S. 74 St. pavement.

The bend (possibly 90 degrees) was in pieces and totally failed. I observed the bottom of the bell to the 6 in. wye connection to be cracked and missing, existing joints for the lateral were gapped and failing.

I instructed Gene Wagner Plumbing that the wye connection would need to be repaired by a spot sanitary relay. Since it was later in the afternoon on Friday, March 7, 2003, Gene Wagner made repairs on the 1505 S. 74 St. 6 in. lateral, then temporarily flumed the lateral.

I returned to the site the morning of Monday, March 10, 2003 and observed Gene Wagner Plumbing making repairs on sanitary main. At approximately 2:00 pm, on March 10, 2003, I returned to see the pipe laying completed (see attached sketch). Slurry backfill was ordered.

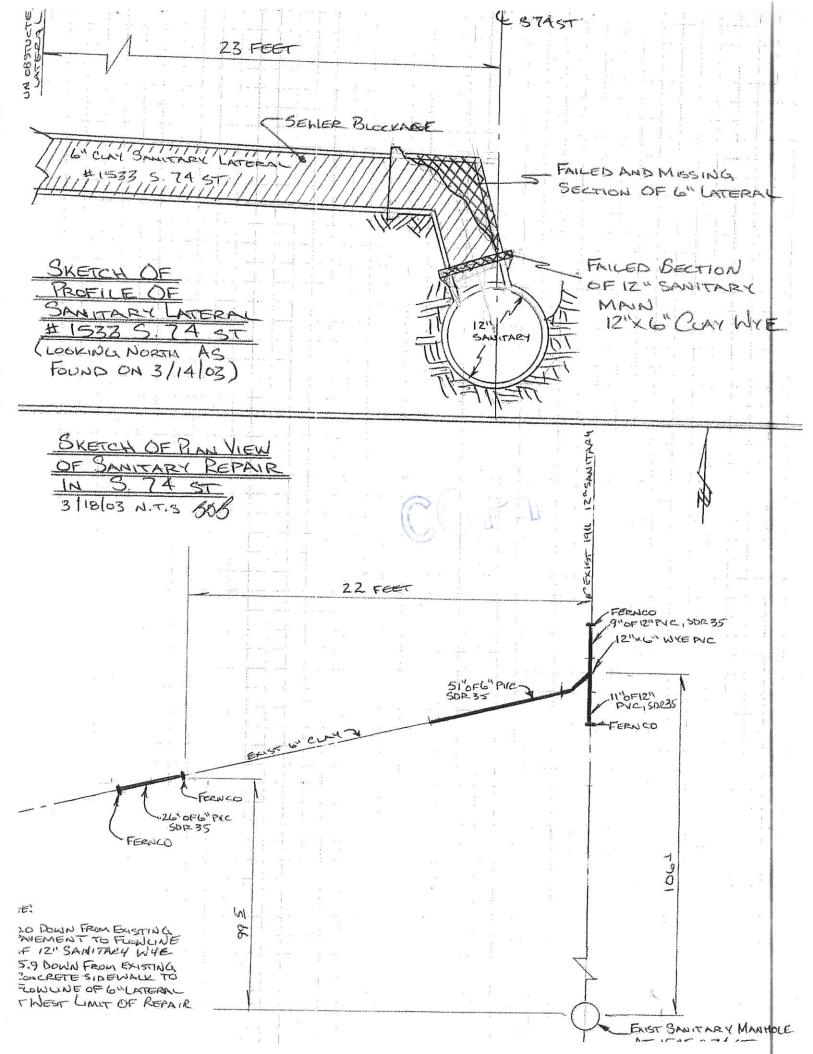
Rozga Plumbing had the lateral for 1533 S. 74 Street exposed at 99.5 feet north of sanitary manhole at approx. 23 feet west of sanitary main. Rozga had Rotor-Rooter "jet" the lateral through a broken section of lateral at 23 feet west of sanitary main. A camera was sent into the lateral east to the main. The existing lateral was found to be in good condition until the fitting at the wye connection. At this point the fitting possibly a bend is seen in pieces. The view of the wye connection did not provide evidence of city

involvement, nor did it disprove. Rozga did use this to locate the wye connection from the surface. Note sanitary lateral angles to the north approx. 6 feet.

Rozga Plumbing began making repairs of the 12" sanitary main and 6" lateral in the morning of Monday, March 17, 2003 and completed the pipe laying in mid-afternoon using (2) 12" "Femco" connection, (1) 6" "Femco" connection, (1) 12"x6" SDR 35 PVC wye, 1.7 feet of 12" SDR 35 PVC pipe, 4.3 feet of SDR 35 PVC pipe. All was backfilled with slurry (see sketch).
