# Sewer lateral Investigation

Failure of Private Sewer Lateral Following 1958 Water Main Installation

ADDRESS: 8606 W LAPHAM ST WEST ALLIS, WI

DATE: 04 JULY 2026

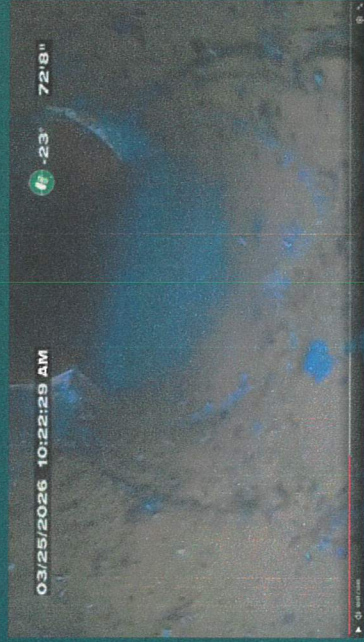
Bottom of First Offset Immediately After Vac Truck

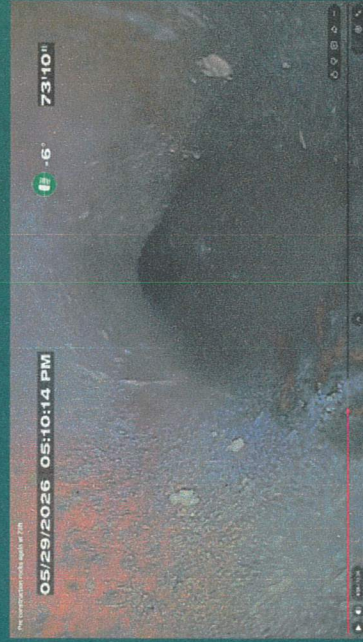
Rocks at Bottom of First Offset Prior to Construction (After Vac Truck)

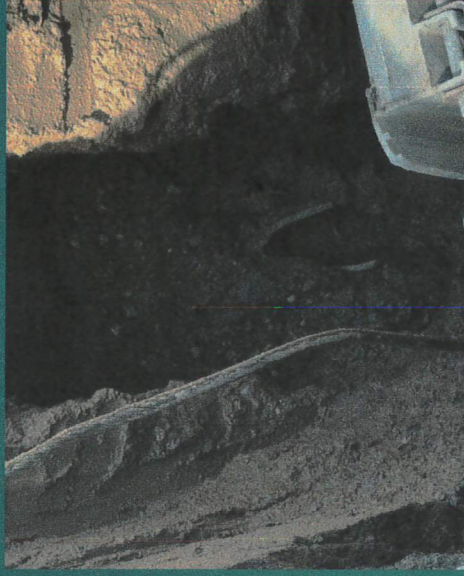
| PHYSICAL OBSERVATION | | SUPPORTS RECONSTRUCTION<br>HYPOTHESIS? | SUPPORTS FAILURE<br>MECHANISM? |
|---|---|---|---|
| 4 | <p><b>Full concrete encasement</b><br/>Entire sewer lateral fully encased beneath the water main, preventing normal repair methods.</p> | ✓ | ✓ |

Lateral Encased in Concrete

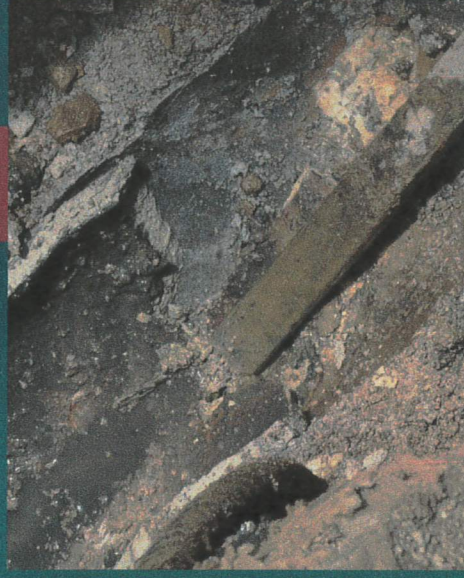
| PHYSICAL OBSERVATION | | SUPPORTS RECONSTRUCTION<br>HYPOTHESIS? | SUPPORTS FAILURE<br>MECHANISM? |
|---|---|---|---|
| 3 | <p><b>Concrete beneath sewer lateral</b><br/>2-3 in. (or more) of concrete observed beneath the sewer lateral below the 30-inch water main.</p> | ✓ | |

Concrete Under Lateral

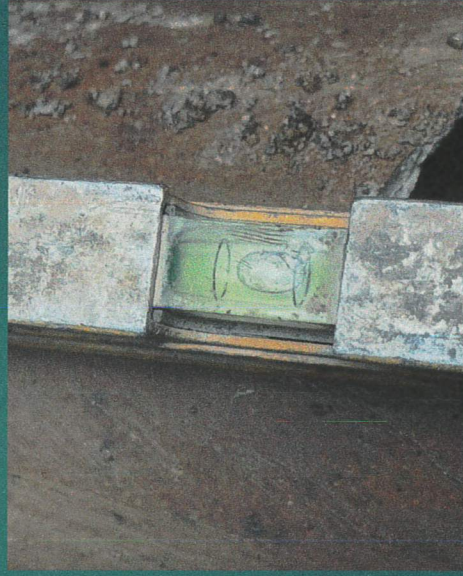
| PHYSICAL OBSERVATION | | SUPPORTS RECONSTRUCTION<br>HYPOTHESIS? | SUPPORTS FAILURE<br>MECHANISM? |
|---|---|---|---|
| 6 | <p><b>Back-pitched section</b><br/>The section immediately beneath the water main was back pitched and permanently encased in concrete.</p> | ✓ | ✓ |

Back Pitch on Pipe (level)

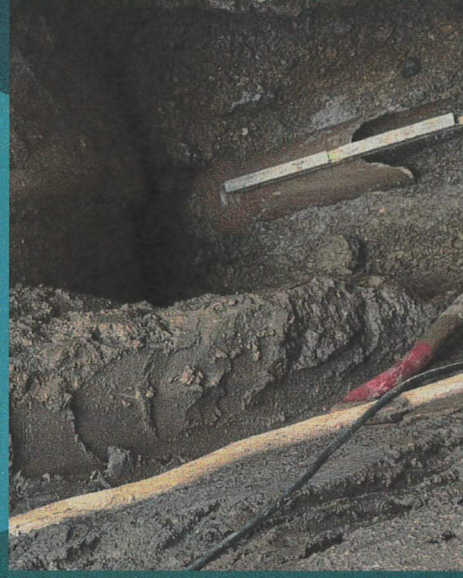
Back Pitch on pipe

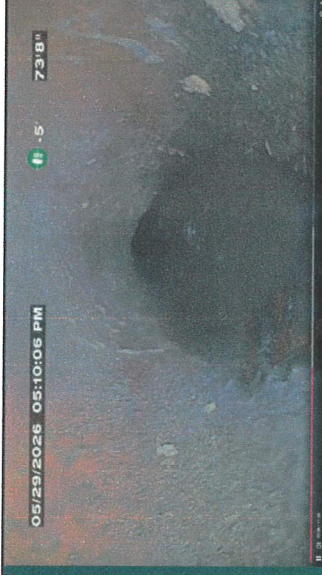
Blockage in  
offset post  
clean out

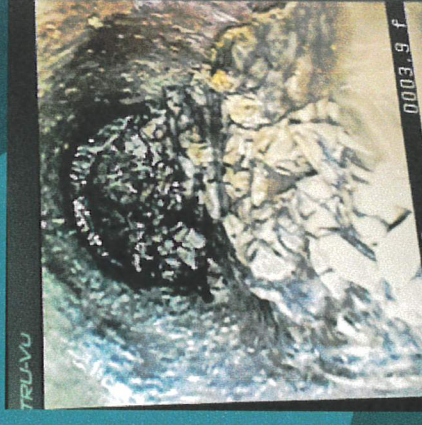
Lateral launch  
of Rocks in last  
5ft of lateral

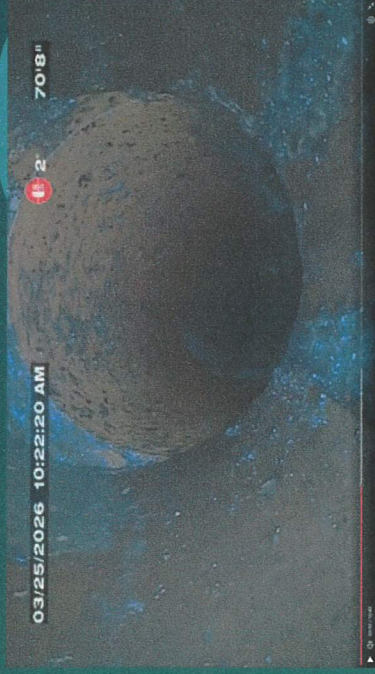
[Link- 02:52](#) – Start of First off set at ~71ft from clean out

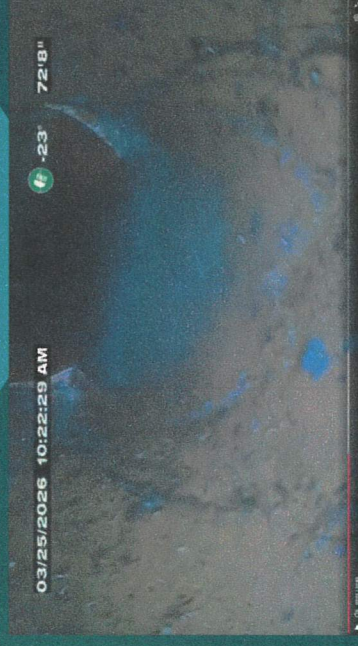
[Link- 03:01](#) – Water and debris reaccumulating immediately after Vacuuming out lateral in back pitched pipe at ~ 73ft from clean out

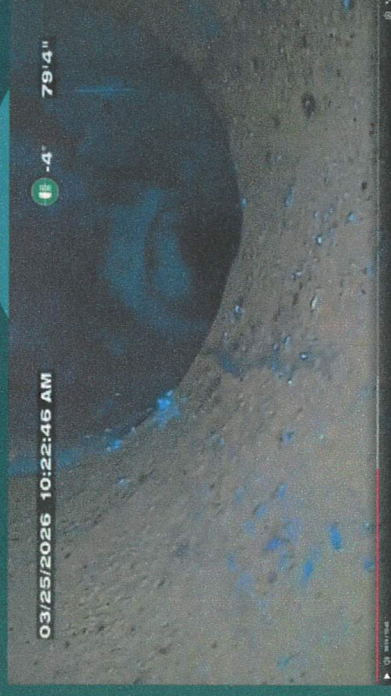
[Link- 03:19](#) – Second off set at ~80 ft from clean out

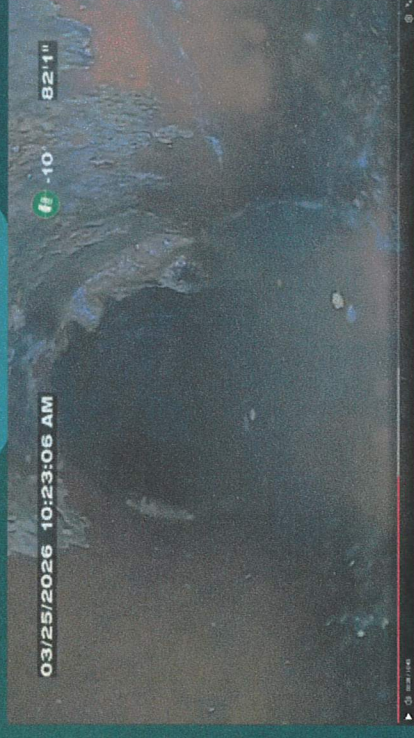
[Link- 03:38](#) – end of second off set and start of double 90's at ~84 ft from clean out

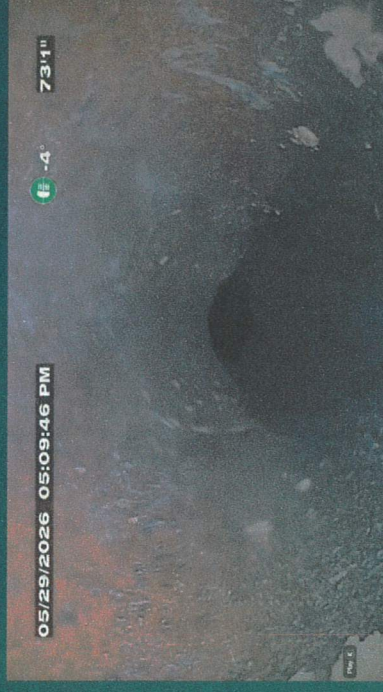
Figure E-1. Sewer camera still showing standing water and rock material at approximately 73 feet following vacuuming.

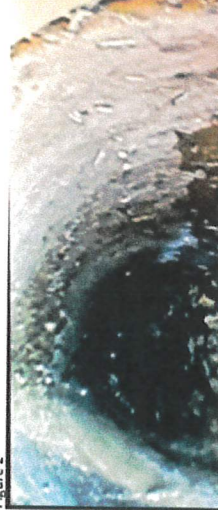
Figure 2

As shown in figures 2 and 3, a large amount of gravel and small stones have blocked the clay lateral, which is why you've been experiencing the backup. This is most likely due to a break in the clay pipe further upstream, and the surrounding soil has been pulled into your pipe.
