Milwaukee County Transit System

December 14, 2020

> RE: Incident Date: October 14, 2020 / Approx. 6:30PM Location: 70th Street & Greenfield Avenue

ACCIDENT REPORT

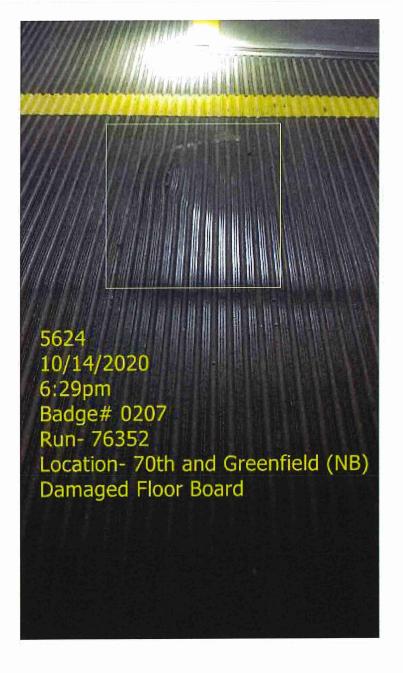
Investigation revealed that there were approximately eight core borings within the crosswalk, with each hole covered with a steel cylinder and steel plate. Operator stated that one of these flat plates was bent and slightly protruding from street. In the process of driving a short distance with it lodged under bus, the cylinder/plate became more bent and started to partially protrude through floor of bus.
