Playground Safety Inspection Report

Member: West Allis

Inspection Date: 8-27-2019

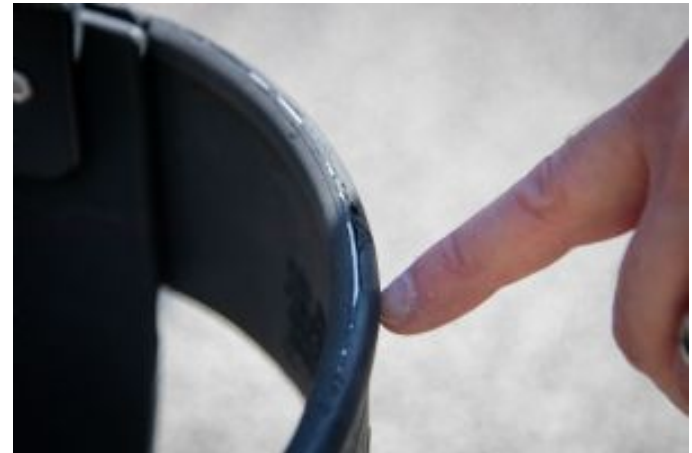
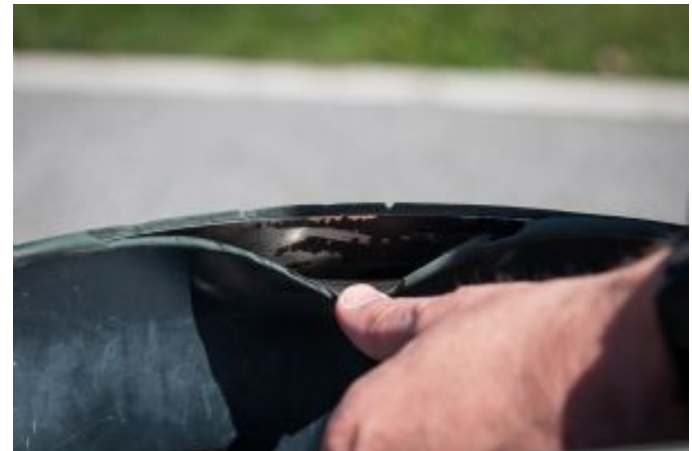
<u>Id</u>	<u>Location</u>	<u>Observation/Recommendation</u>
10401	Reservoir Park	Sharp Points, Corners or Edges All metal edges should be rolled or have rounded capping. CPSC 3.4

This applies to two of the tot swings, they should be replaced due to the metal being exposed. Sharp points, corners, or edges on any part of the playground or playground equipment may cut or puncture a child's skin. Sharp edges can cause serious lacerations if protective measures are not taken.

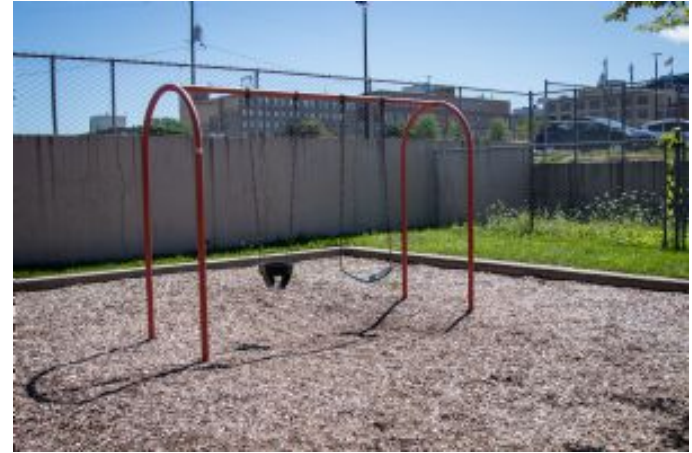
Id Location
10402 McKinley Park

Observation/Recommendation
Protective Surface Material

The protective surfacing material throughout this playground is inadequate. The appropriate amount of protective surfacing material must be installed based on the critical height of the playground equipment.

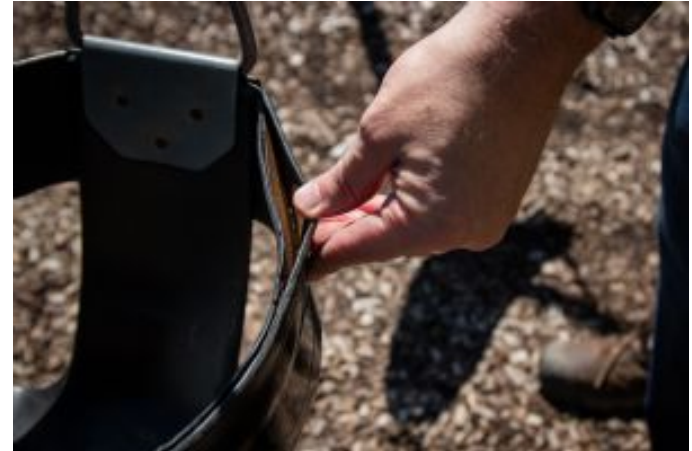
<u><i>Id</i></u>	<u><i>Location</i></u>	<u><i>Observation/Recommendation</i></u>
10403	McKinley Park	Sharp Points, Corners or Edges All corners, metal and wood, should be rounded. CPSC 3.4 Recommendation This applies to the tot swing that has exposed metal, it should be replaced. Sharp points, corners, or edges on any part of the playground or playground equipment may cut or puncture a child's skin. Sharp edges can cause serious lacerations if protective measures are not taken.

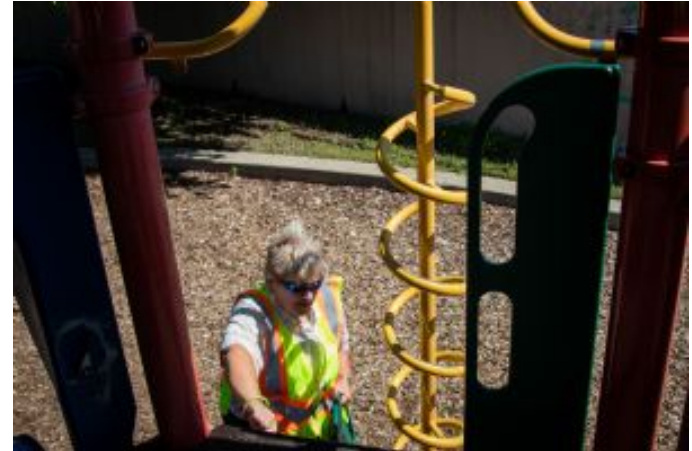
<u><i>Id</i></u>	<u><i>Location</i></u>	<u><i>Observation/Recommendation</i></u>
10404	McKinley Park	<p>Guardrails and Protective Barriers</p> <p>Guardrails and protective barriers are used to minimize the likelihood of accidental falls from elevated platforms. Protective barriers provide greater protection than guardrails and should be designed to discourage children from climbing over or through the barrier. CPSC 5.1.3</p>

The protective barrier on the platform above the spiral climber has been damaged and is missing on one side. (It was left at the playground and Linda took it back to DPW) The guardrails and barriers should completely surround any elevated platforms except for the maximum of 15 inches that is needed to access play equipment.

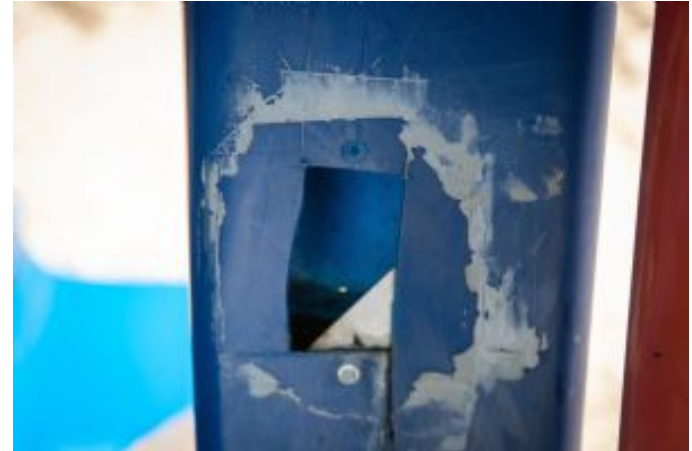
<u><i>Id</i></u>	<u><i>Location</i></u>	<u><i>Observation/Recommendation</i></u>
10405	McKinley Park	Sharp Points, Corners or Edges There should be no sharp edges on slides. Pay special attention to metal edges of slides along the sides and at the exit. CPSC 3.4

This applies to the damaged opening/hole at the top of the slide and it has a small metal plate inside of it. Sharp points, corners, or edges on any part of the playground or playground equipment may cut or puncture a child's skin. Sharp edges can cause serious lacerations if protective measures are not taken.

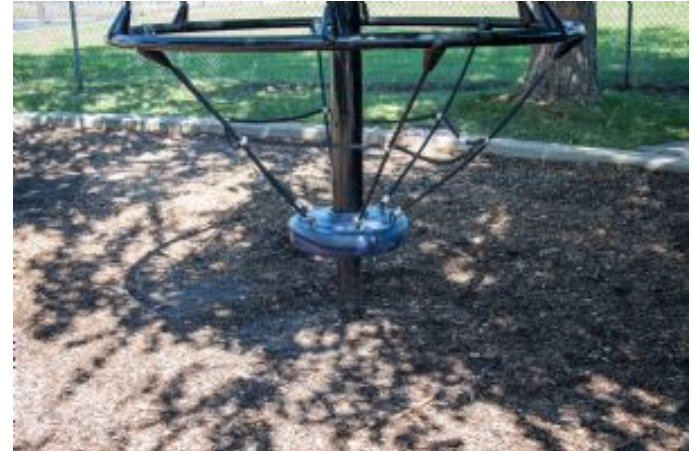
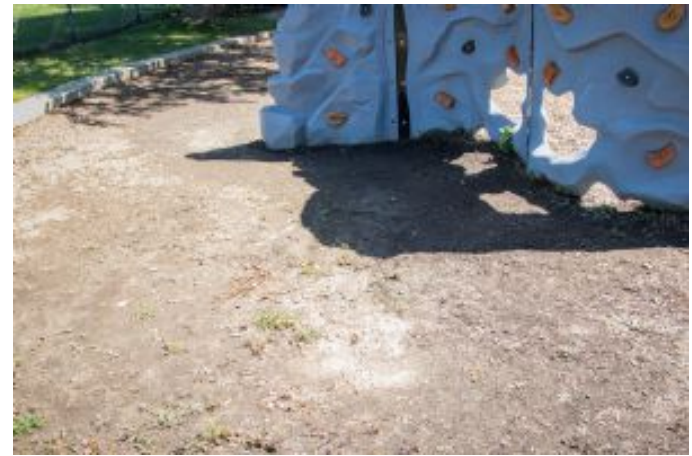
Id Location
10406 McKinley Park

Observation/Recommendation
Protective Surface Material

The protective surfacing in these areas is inadequate. The appropriate amount of protective surfacing material must be installed based on the critical height of the playground equipment.

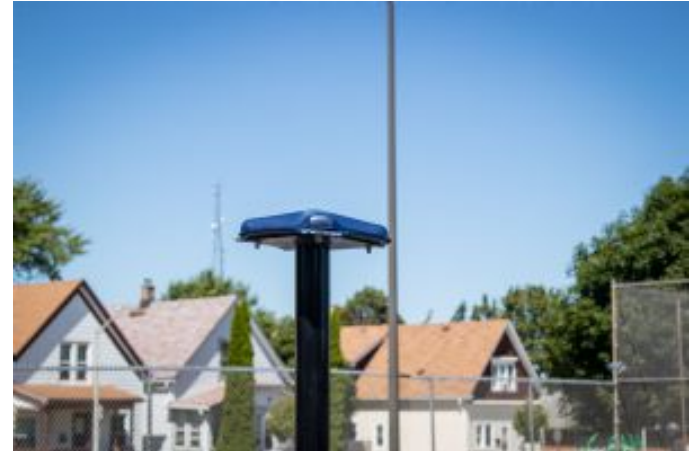
<u><i>Id</i></u>	<u><i>Location</i></u>	<u><i>Observation/Recommendation</i></u>
10407	McKinley Park	Maintenance Inspections alone do not constitute a comprehensive maintenance program. Any problems found during the inspection should be noted and fixed as soon as possible. All repairs and replacements of equipment parts should be completed following the manufacturer's instructions. CPSC 4.2

The ball return game on the asphalt area has broken off leaving a pole with the plastic mount. Is this going to be replaced? If not, it should be removed. All hazards found during inspections should be eliminated as soon as possible. Repairs and replacements should also be documented.

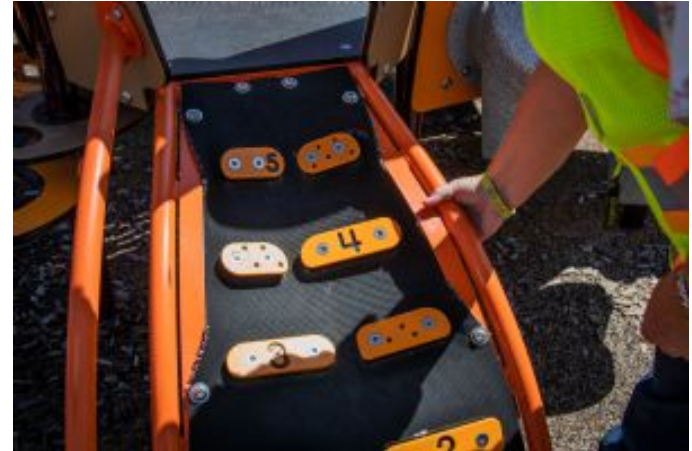
Id Location
10408 Liberty Heights
Park

Maintenance

This small climber on the small play structure is equipped with a rubber mat affixed to the support poles and the rubber matting has been pushed in and is now partially under the support poles. This could be fixed by adding additional hardware along the sides of the mat. My recommendation is to notify the manufacturer of this issue and see what solution they offer to eliminate this from occurring.

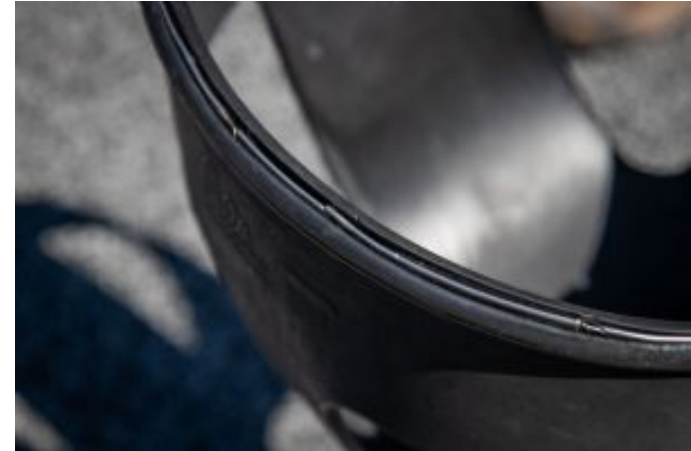
<u>Id</u>	<u>Location</u>	<u>Observation/Recommendation</u>
10409	Liberty Heights Park	Sharp Points, Corners or Edges All metal edges should be rolled or have rounded capping. CPSC 3.4 Recommendation This applies to the exposed metal on the tot swing, the tot swing should be replaced. Sharp points, corners, or edges on any part of the playground or playground equipment may cut or puncture a child's skin. Sharp edges can cause serious lacerations if protective measures are not taken.

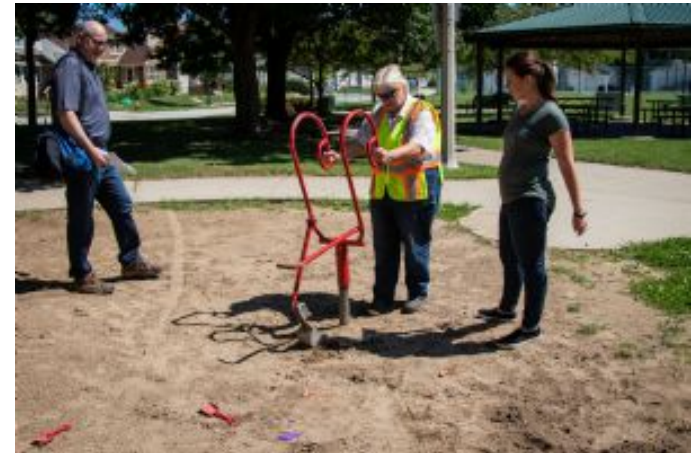
<u>Id</u>	<u>Location</u>	<u>Observation/Recommendation</u>
10410	Liberty Heights Park	<p>Maintenance</p> <p>Inadequate maintenance of equipment has resulted in injuries on playground. Because the safety of playground equipment and its suitability for use depend on good inspection and maintenance, the manufacturer's maintenance instructions and recommended inspection schedules should be strictly followed. A comprehensive maintenance program should be developed for each playground. All playground areas and equipment should be inspected for excessive wear, deterioration, and any potential hazards.</p> <p>CPSC 4.1</p>

The sand digger is broken and should be repaired or removed from the playground.

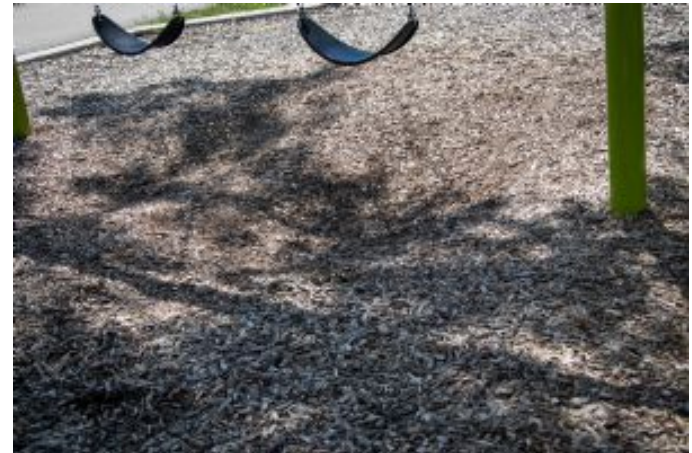
Id Location
10412 Klentz Park

Observation/Recommendation
Protective Surface Material

The areas under the swings are deeply rutted out and the protective surfacing material should be raked and maintained back into these areas. The appropriate amount of protective surfacing material must be installed based on the critical height of the playground equipment.

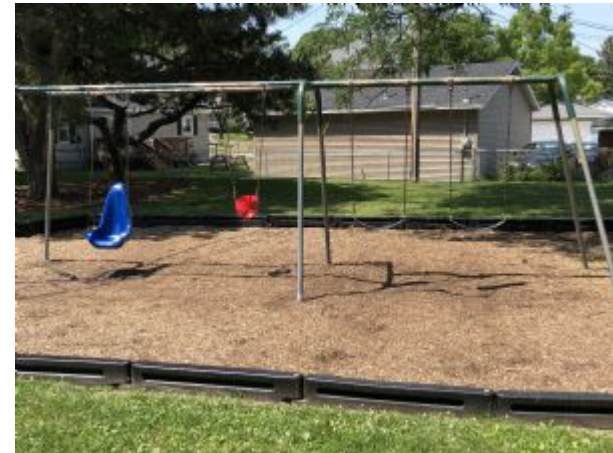
Id Location
10413 Rogers Park

Observation/Recommendation
Protective Surface Material

The areas under the swings are deeply rutted out and the protective surfacing material should be raked and maintained back into these areas. The appropriate amount of protective surfacing material must be installed based on the critical height of the playground equipment.

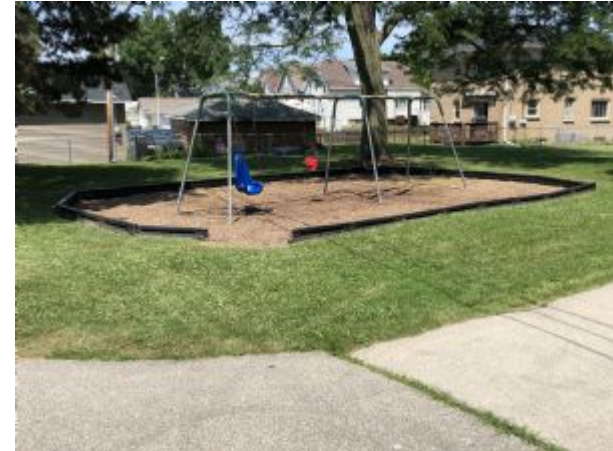
Id Location
10414 Rogers Park

Accessibility

An ADA accessible route must be provided to get to the playground and also to gain access to all accessible play structures or components within the playground.

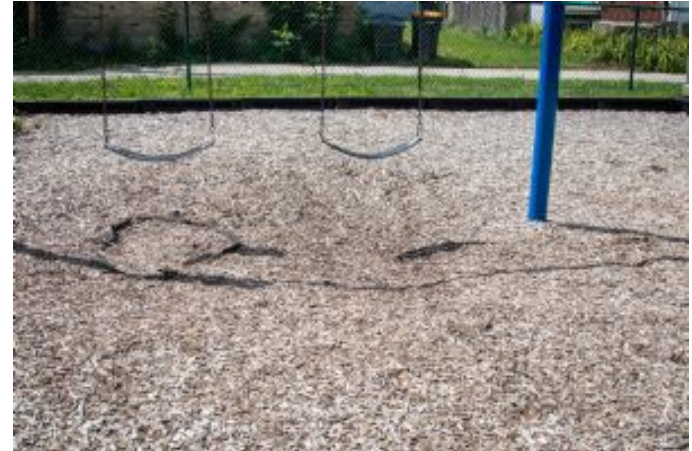
<u>Id</u>	<u>Location</u>	<u>Observation/Recommendation</u>
10415	Rogers Playground	Protective Surface Material

The areas under the swings are deeply rutted out and the protective surfacing should be raked back into these areas and properly maintained. The appropriate amount of protective surfacing material must be installed based on the critical height of the playground equipment.

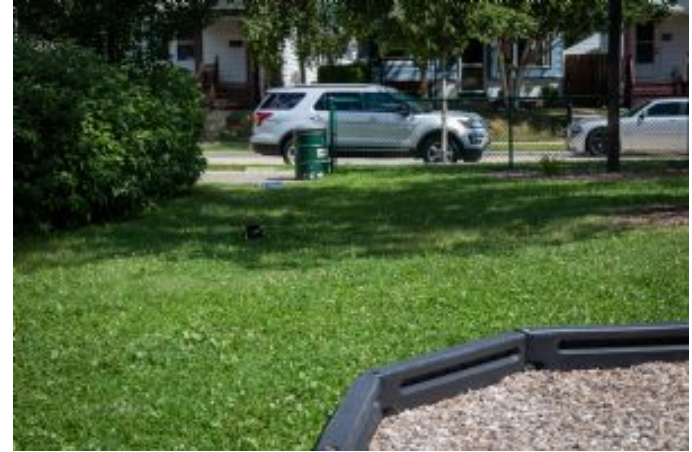
<u><i>Id</i></u>	<u><i>Location</i></u>	<u><i>Observation/Recommendation</i></u>
10416	Rogers Playground	Accessibility

An ADA accessible route must be provided to get to the playground and also to gain access to all accessible play structures or components within the playground.

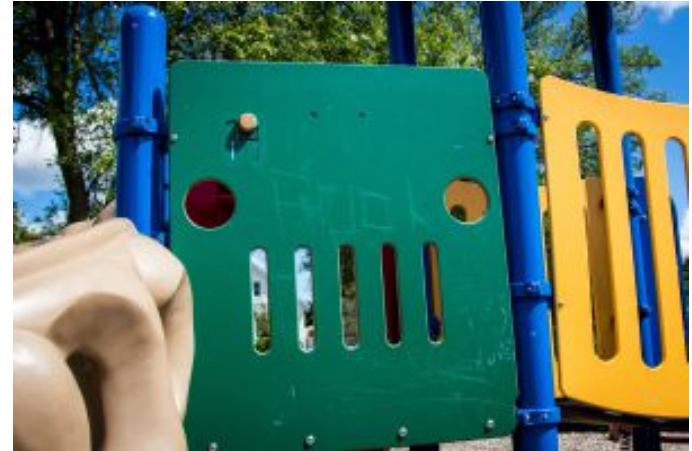
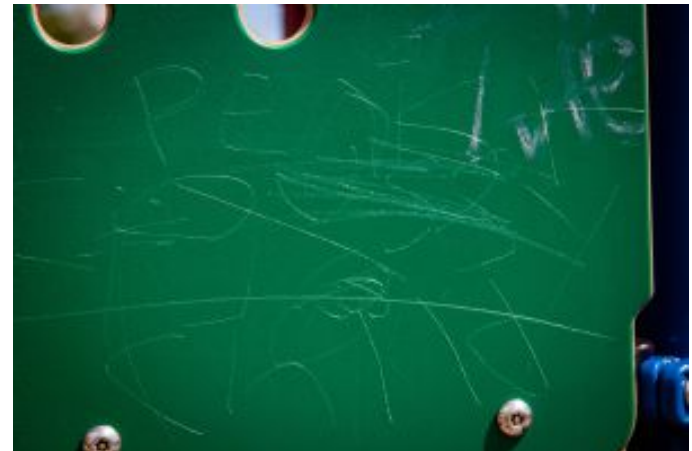
<u>Id</u>	<u>Location</u>	<u>Observation/Recommendation</u>
10417	Rogers Playground	Maintenance

There is graffiti on the green protective panel that has been etched into the panel.
