City of West Allis Matter Summary

Resolution authorizing and directing the City Engineer to pay for sanitary sewer lateral repairs at 801 South 60th Street in the amount of \$24,405.08.

RE: Claim Against the City of West Allis by Rozga Plumbing and Heating Corporation for Sanitary Relay and Lateral Reconnects at 801 S. 60 St.

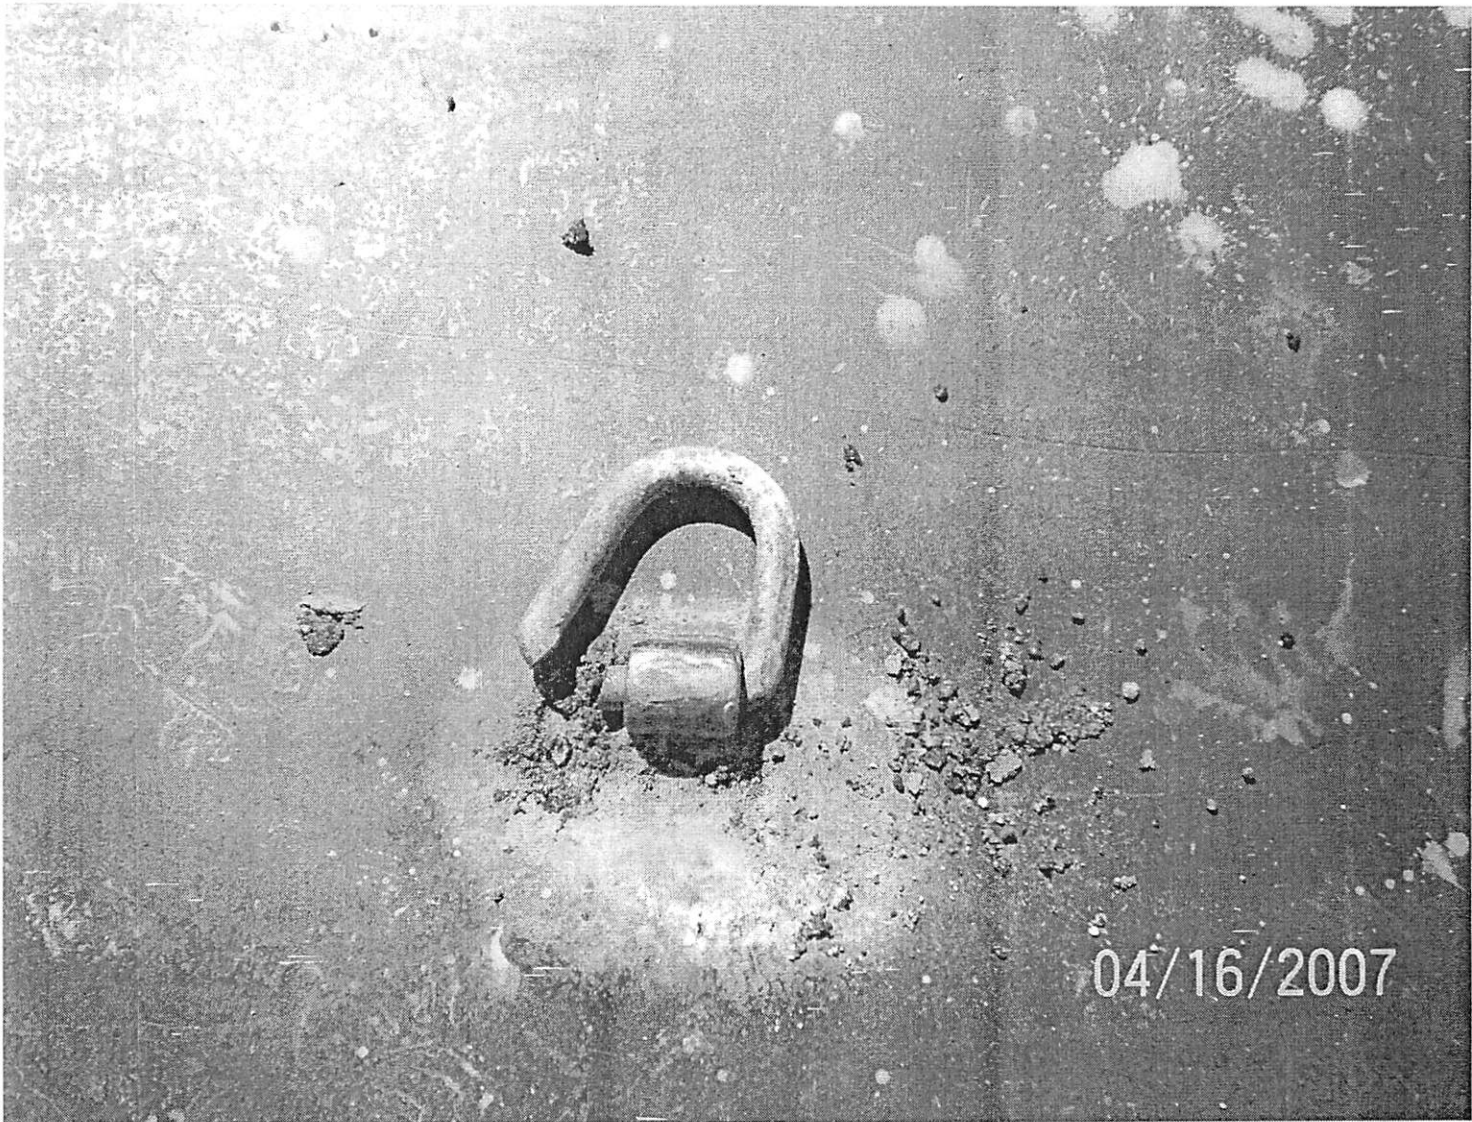
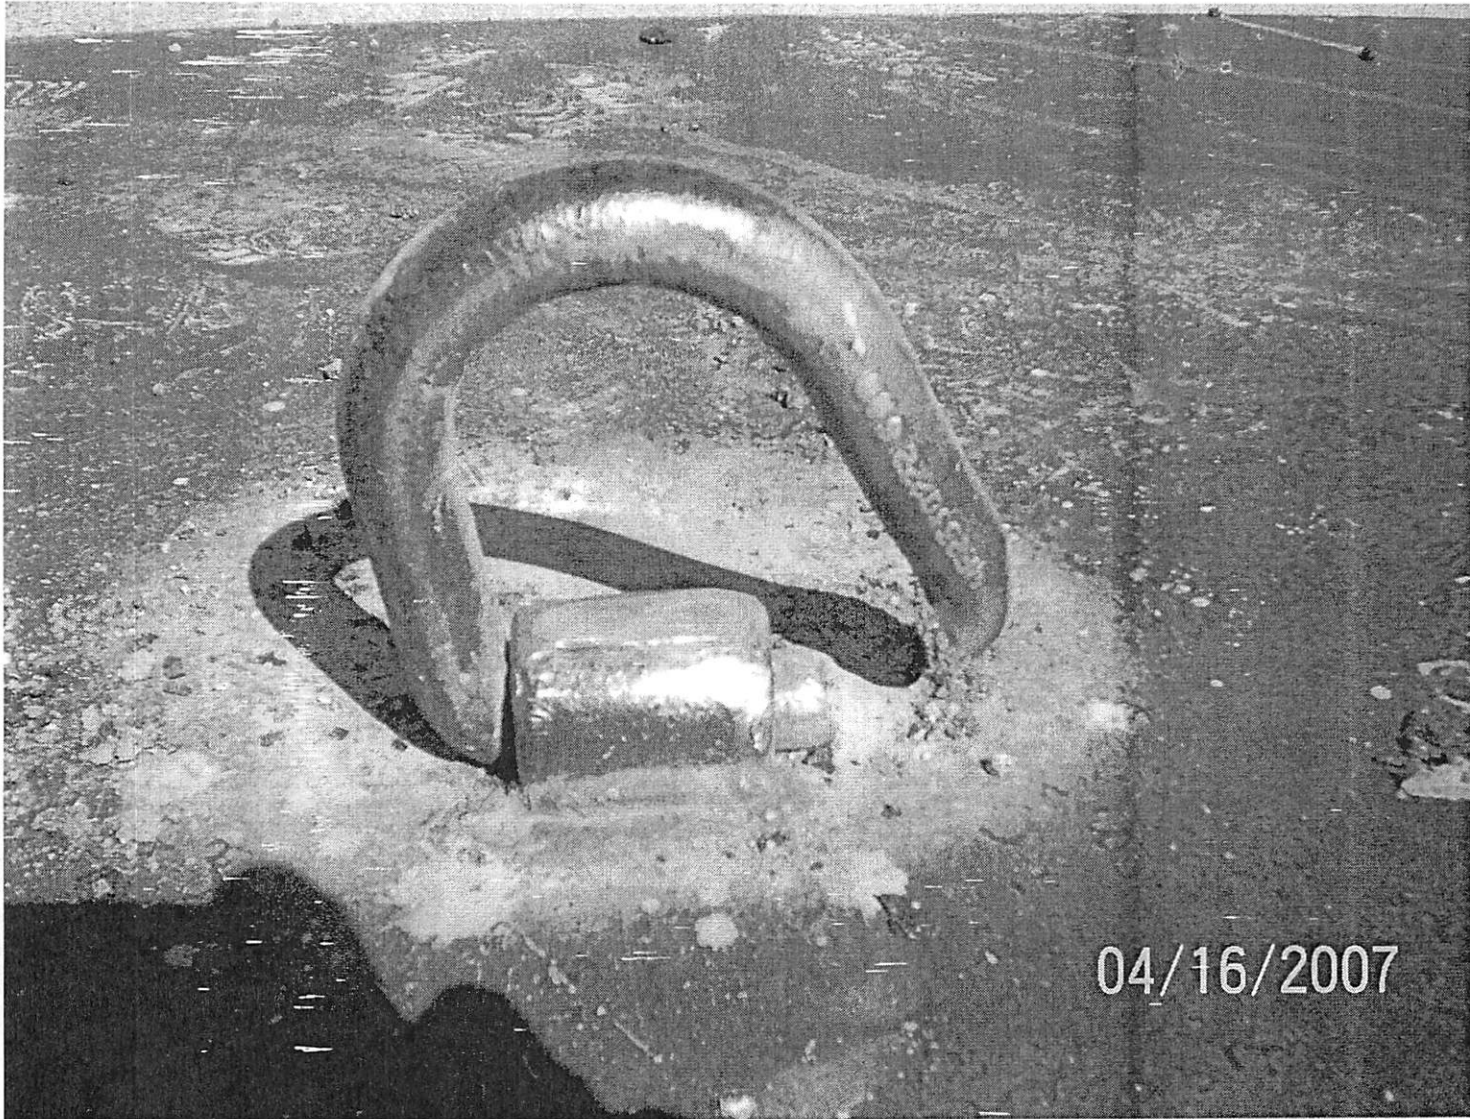
- Attach:
- Rozga Claim 7-6-07
 - Email John Krzyzaniak 4-17-07
 - WAPD Call Report 4-11-07
 - Televising Report 7-29-04
 - Forest Cvikel Call in note 4-13-07
 - (2) Rozga provided pictures of plates with damaged rings
 - Weather Sheet 4-11-07

As per our discussion, I have already e-mailed you the pictures of the damaged road plates we repaired.

1.50	2-man Excavation Crew, 4-16-07, back at the shop our damaged road plates were worked on. Lifting rings had to be cut off, plates ground down and new rings welded back on.	174.00	261.00

- Pinning in place consists of the use of steel pins with caps placed through holes in the four corners of the steel plates and into holes drilled into the pavement to prevent horizontal movement. Additionally, the lifting rings on the Rozga plates were not protected in any way, such as square steel stock welded to the plate adjacent to the rings to prevent damage to the rings. This is also a standard industry practice.

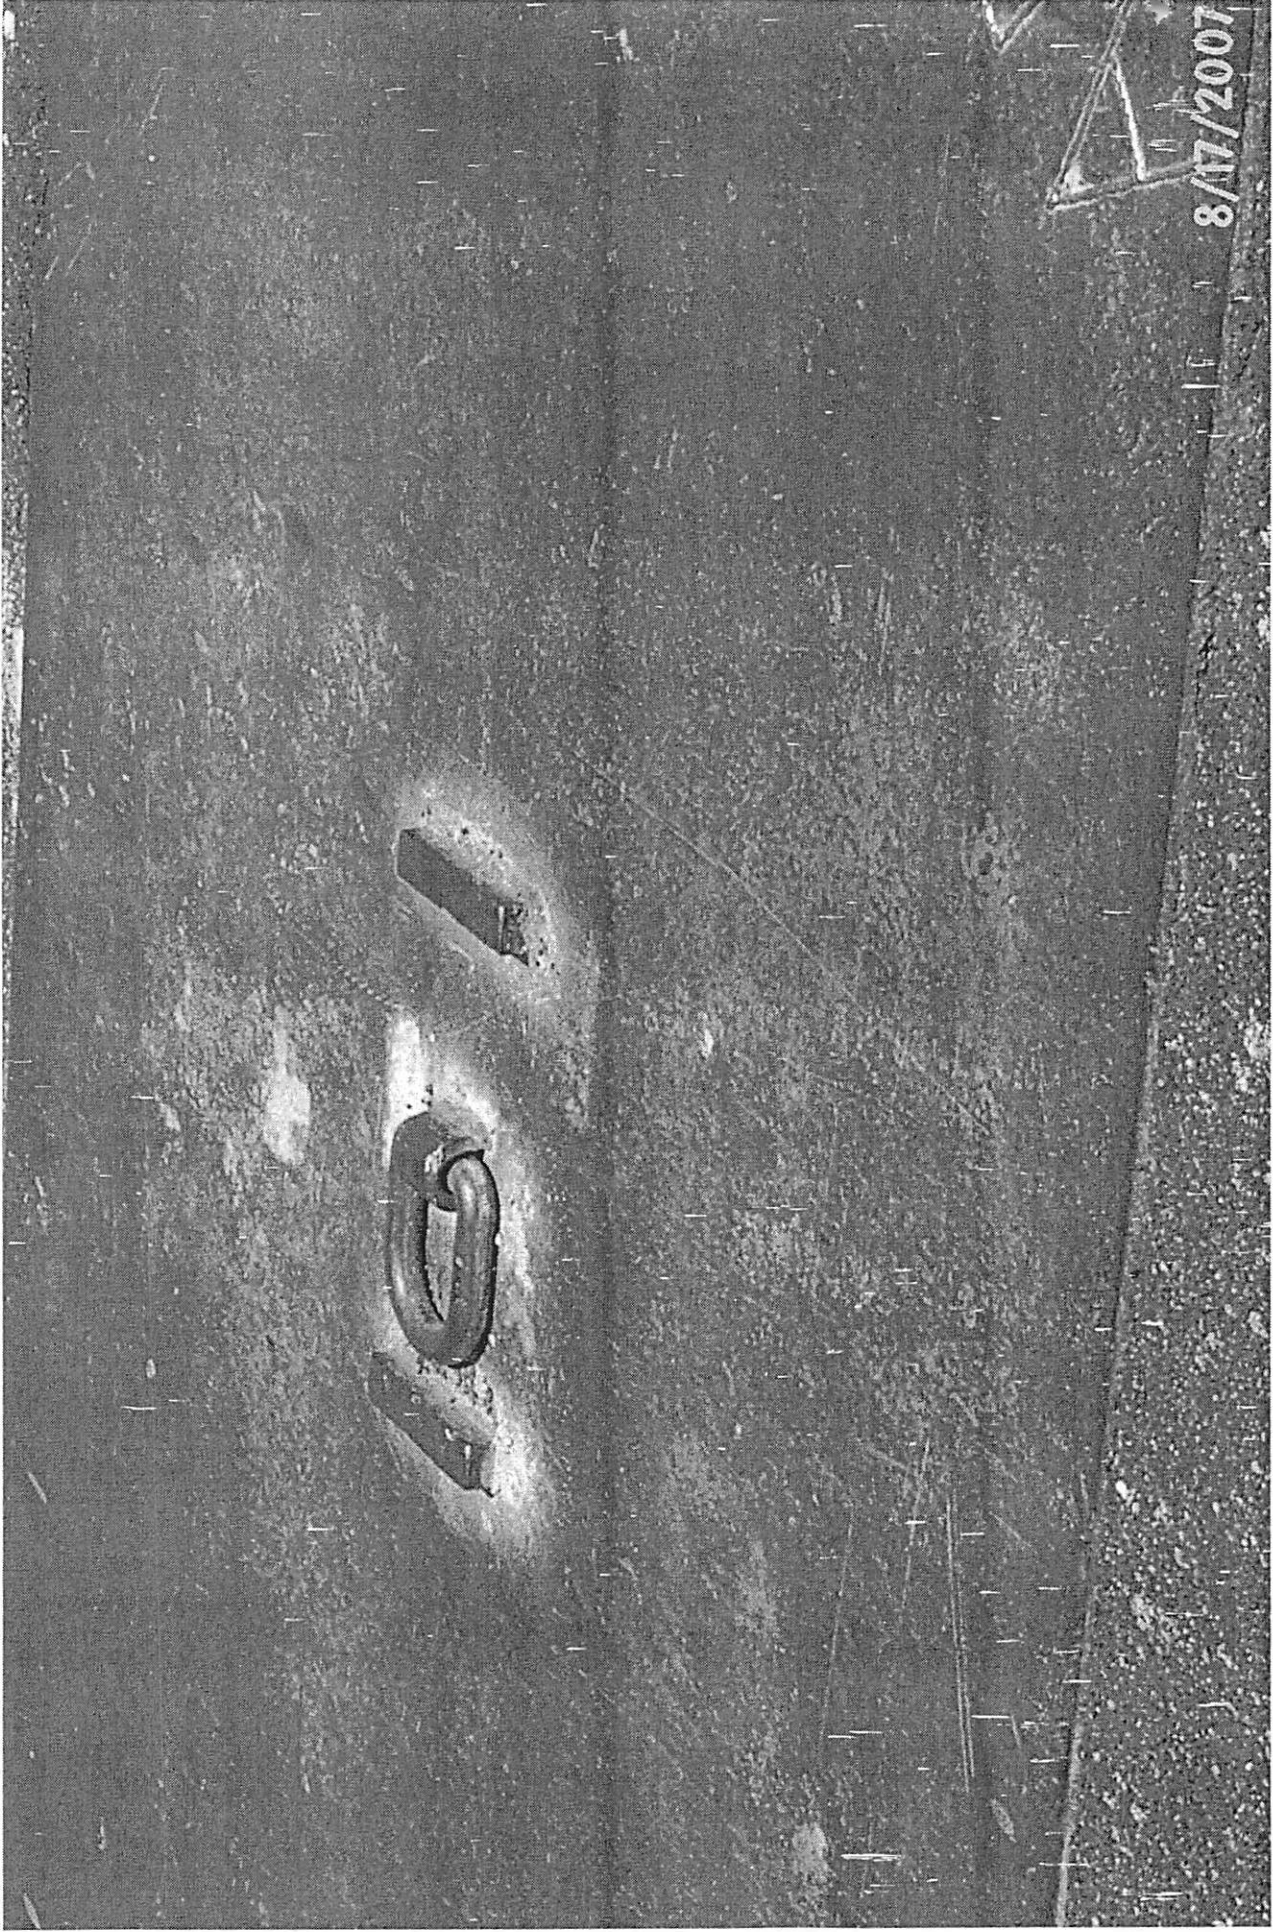
Example of steel square stock welded to road plate to protect lifting rings
