Resolution authorizing and directing the City Engineer to pay for sanitary sewer lateral repairs at 801 South 60th Street in the amount of \$24,405.08.

MEMORANDUM

RE: Claim Against the City of West Allis by Rozga Plumbing and Heating Corporation for Sanitary Relay and Lateral Reconnects at 801 S. 60 St.

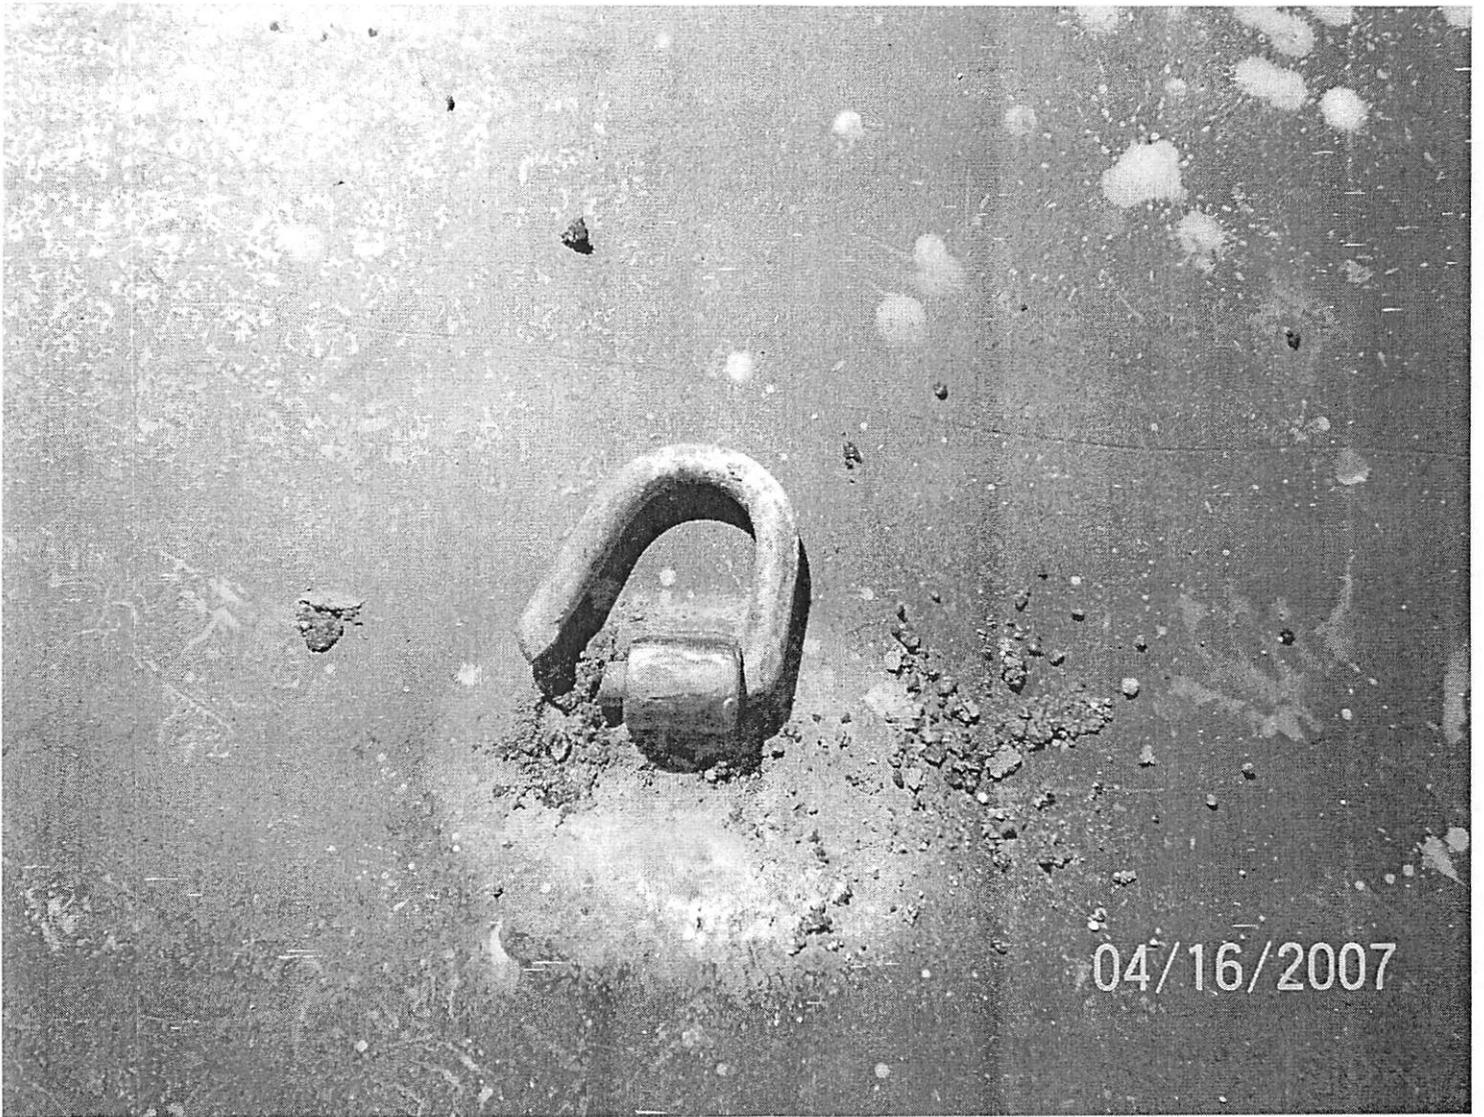
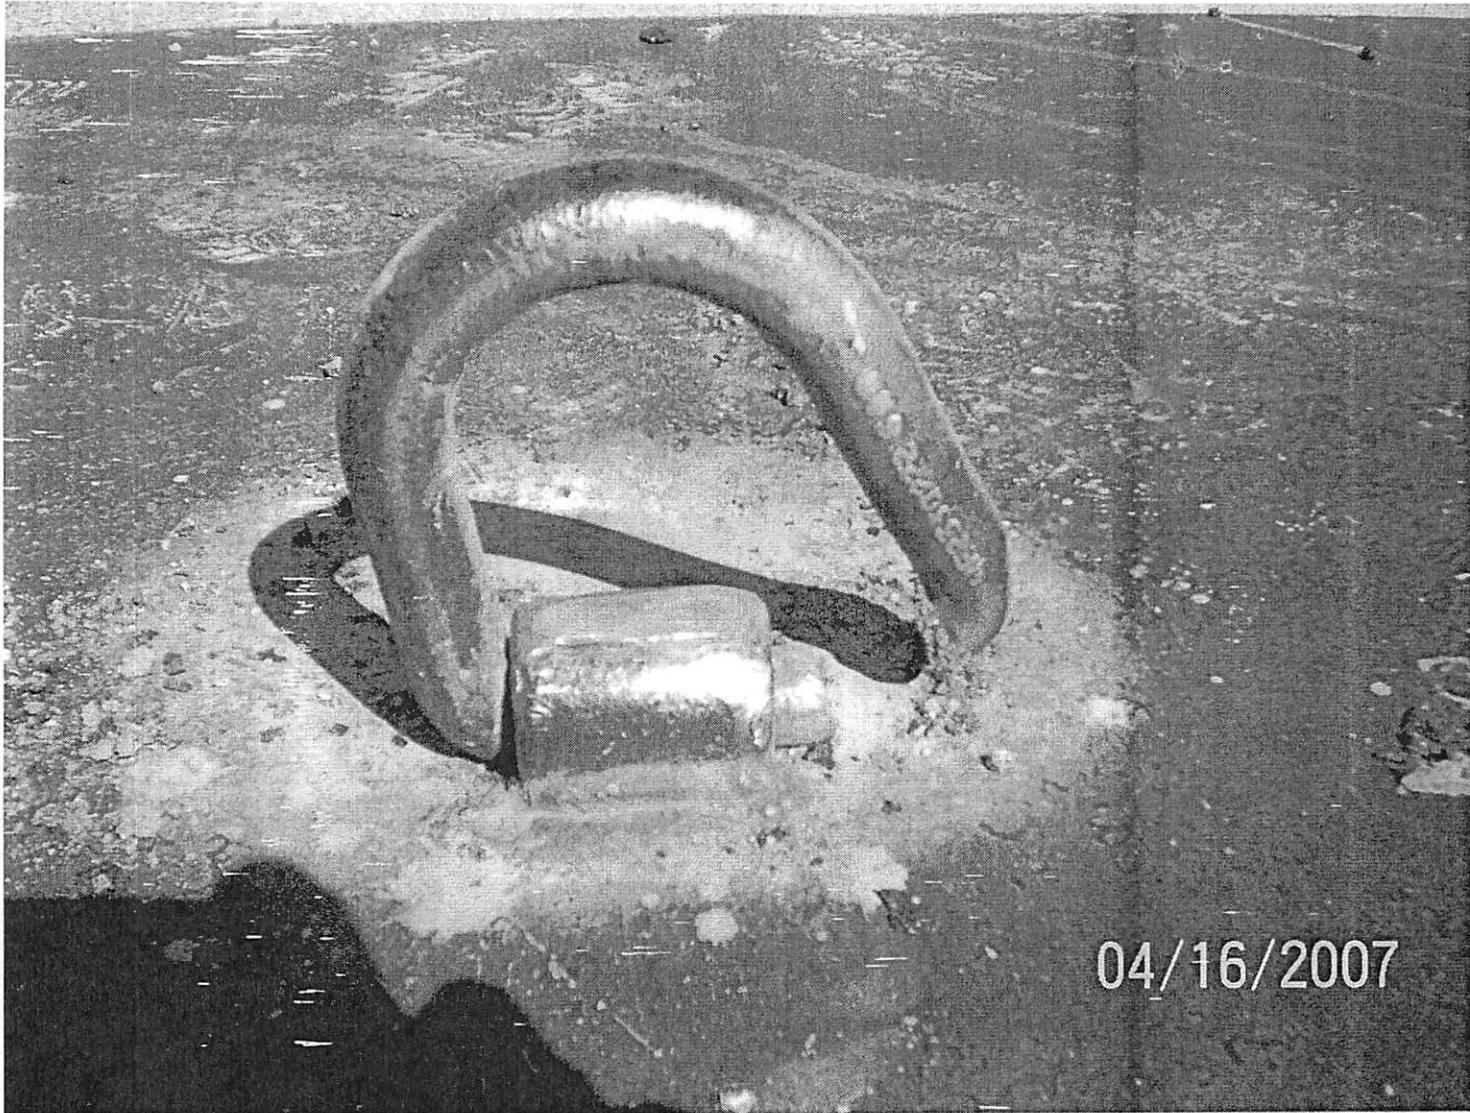
- Attach:
- Rozga Claim 7-6-07
 - Email John Krzyzaniak 4-17-07
 - WAPD Call Report 4-11-07
 - Televising Report 7-29-04
 - Forest Cvikel Call in note 4-13-07
 - (2) Rozga provided pictures of plates with damaged rings
 - Weather Sheet 4-11-07

1.50	2-man Excavation Crew, 4-16-07, back at the shop our damaged road plates were worked on. Lifting rings had to be cut off, plates ground down and new rings welded back on.	174.00	261.00

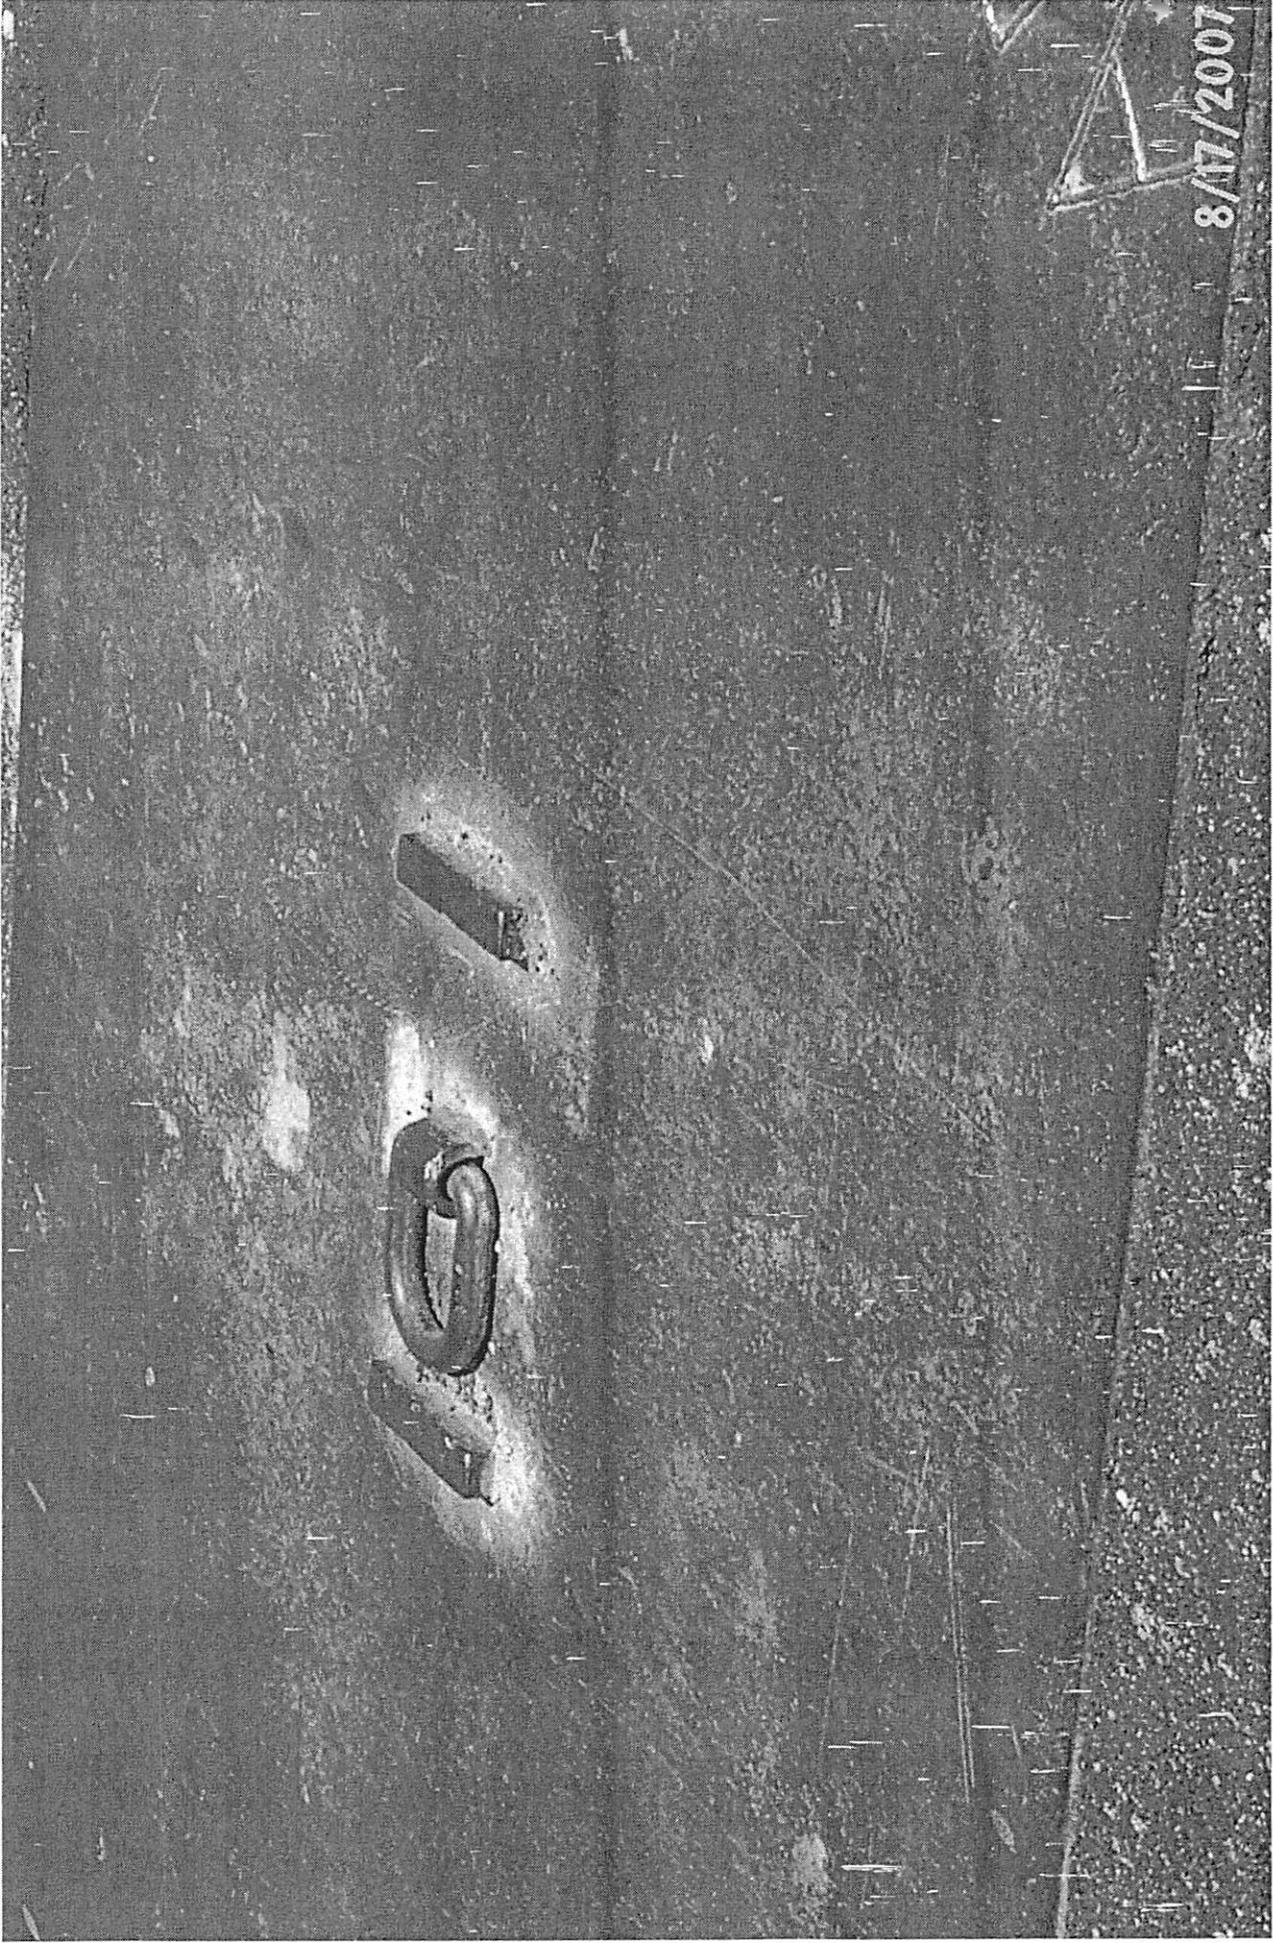
- Pinning in place consists of the use of steel pins with caps placed through holes in the four corners of the steel plates and into holes drilled into the pavement to prevent horizontal movement. Additionally, the lifting rings on the Rozga plates were not protected in any way, such as square steel stock welded to the plate adjacent to the rings to prevent damage to the rings. This is also a standard industry practice.

Example of steel square stock welded to road plate to protect lifting rings
