STAFF REPORT
WEST ALLIS PLAN COMMISSION
Wednesday, March 28, 2018
6:00 PM
ROOM 128 – CITY HALL – 7525 W. GREENFIELD AVE.

- 4A. Special Use Permit for Pho Saigon, a proposed restaurant, to be located at 10534 W. Greenfield Ave.**
- 4B. Site, Landscaping and Architectural Plans for Pho Saigon, a proposed restaurant, to be located at 10534 W. Greenfield Ave., submitted by Barry Yang, AIA, d/b/a Barry C. Yang Architect. (Tax Key No. 444-0511-001 and 444-0513-000)**

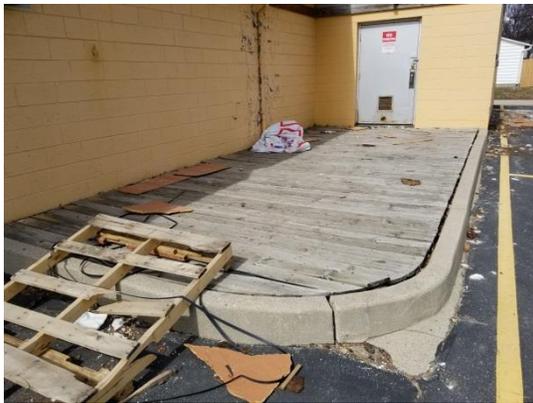
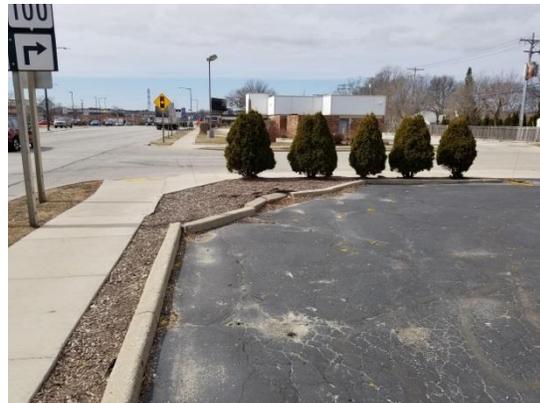
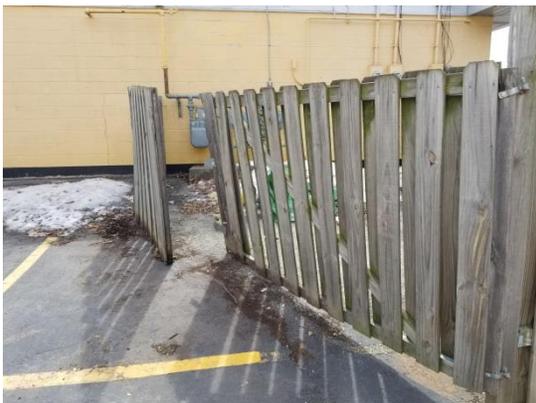
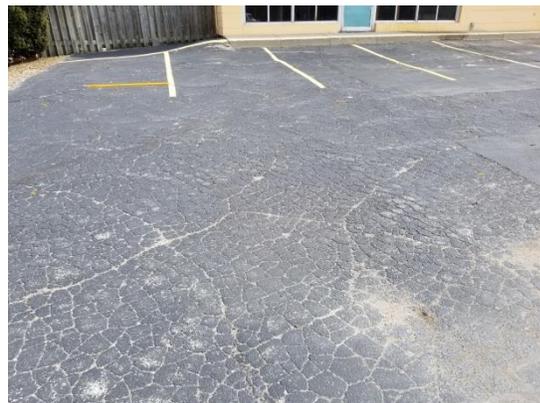
Minor changes to the parking configuration are also proposed, though the layout will remain very similar to what currently exists. A loading zone shown to the north of the building would adjoin space currently used as a refuse area. The refuse area is currently screened by a six foot wood fence. There are currently no proposed improvements to the fence, though staff recommends a new fence for this area as the current one is damaged in several areas.

There are a few additional details that staff would like to see on the landscape plan. Some of the curbing, specifically the southwestern corner of the site, is broken up. Fixing areas with broken curbing is not currently shown on the site, and staff would recommend adding a condition of approval to address the curbing. In addition, the current patio area features wood planks that are dilapidated. The current plans show that the patio area will be extended, although no improvement to the current patio area is proposed. Staff recommends removing all of the wood planks and infilling with a durable material such as concrete.

Currently, the two parking areas are in different states of repair. The asphalt of parking area to the east of the building is in good condition. However, the area west of the building has several uneven areas and cracked asphalt. There are no proposed improvements to the parking area at this time, but staff recommends that this area be repaired.

1. Revised Site, Landscaping and Architectural Plans being submitted to the Department of Development to show the following: (a) plans to note curbing repair along the southwestern corner of the site; (b) pavement repair being noted within the west parking area; (c) exterior color, door and window details; (d) new wood refuse enclosure being indicated on plan (provide detail); (e) removal of the damaged checkered accent panel and LED lighting along the roofline; (f) Exterior lighting details being provided. Existing soffit lighting being repaired, and a decorative style of exterior signage lighting is recommended; (g) removal of the existing patio wood plank surface within the existing patio area for a more durable paved surface; (h) replace the east and west side exterior doors. Details being provided; (i) curb cut geometry along S. 106 St. being corrected on plan to fit as built situation; (j) removal of the existing wood header board on the east side of the building (previously supported a pergola feature which no longer exists); (k) bike rack/parking being noted on site and details of an inverted-u rack being noted. Contact Steve Schaer, Planning Manager at (414) 302-8466 with any questions.

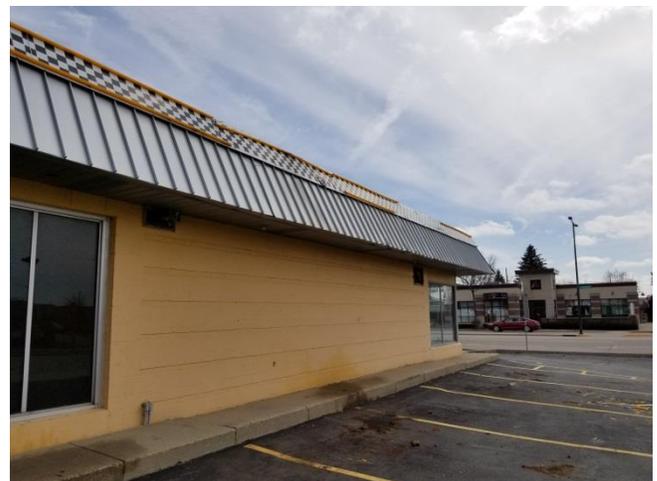
The applicant is proposing to repaint the building exterior, though the color details will need to be provided to staff. Earth tones are recommended. With the interior space changing drastically, the exterior functionality will also change. Customer entrances are on the west and south side of the building with both featuring vestibule areas. There are currently two doors on the south side of the building, one being unused (and bolted shut)

and the other the previously mentioned customer entrance. There will be two other entrances, both on the east side of the building; one will access the patio area, and the other will be a delivery entrance. There is also a third door on the east side of the building that will be removed and filled in with CMU. On the southeast corner of the building there is a window that is currently painted over, though it is proposed to be opened up as part of the renovations.

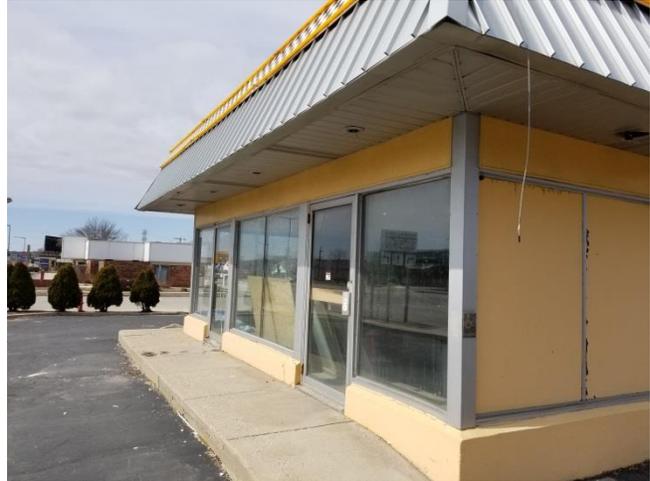
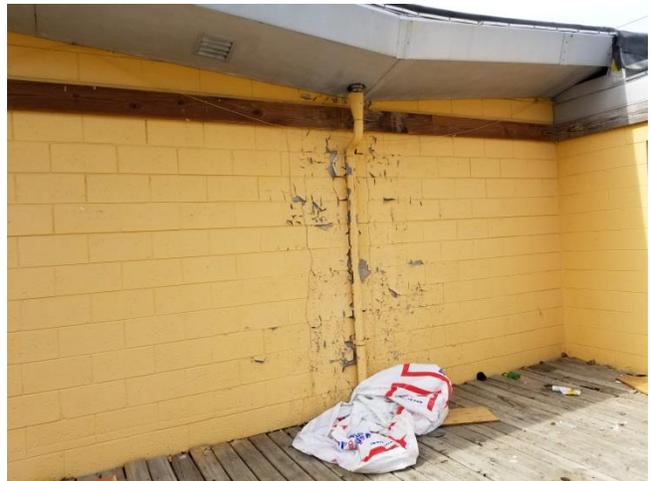
Wood accent panels are featured along the east side of the building and should be removed as they are worn and slightly damaged. The applicant has not proposed to remove the wood panels, so the removal of them should be included in the elevations.

Initially, the applicant proposed to remove the current pitched metal parapet and replace it with a standing seam vertical parapet. However, project costs and staff suggestions led to other priority improvements. As a result, the current angled parapet will remain, although it should be modified to better suit the proposed restaurant. The current parapet features a checkered accent area that was a remnant from Sammy's. Staff recommends removing this, as it is not denoted in the elevations provided. Additionally, there are damaged areas of the parapet that need to be repaired and called out on the elevations.
