# Sewer lateral Investigation

Concrete Encasement of Private Sanitary Sewer Lateral Beneath City's 30in Water Main

ADDRESS: 8606 W LAPHAM ST WEST ALLIS, WI

PREPARER: DESTON FLAMINI

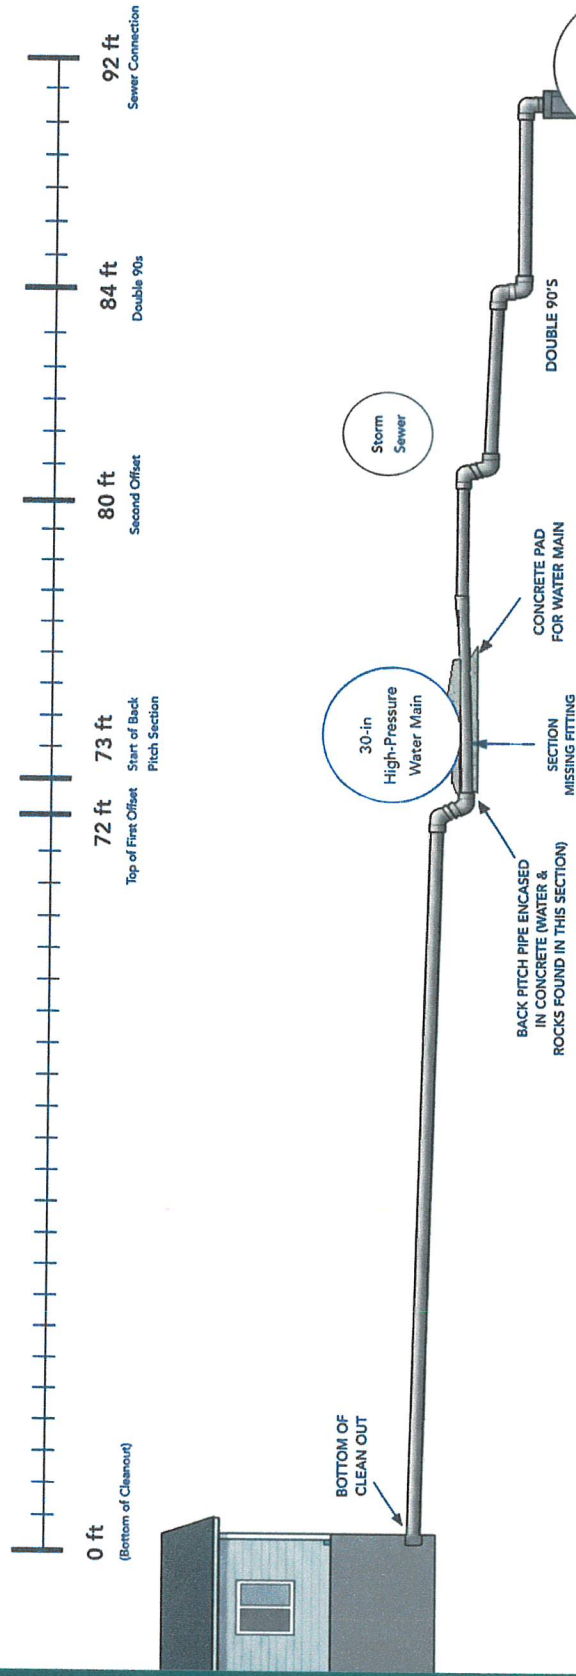
## Sewer Lateral Profile – 8606 W. Lapham St.

Digital rendering of existing utilities and critical measurements (not to scale).

Note: Measurements are based off sewer camera footage and field measurements. (see appendix)

See Appendix C - E for Sewer Camera Footage

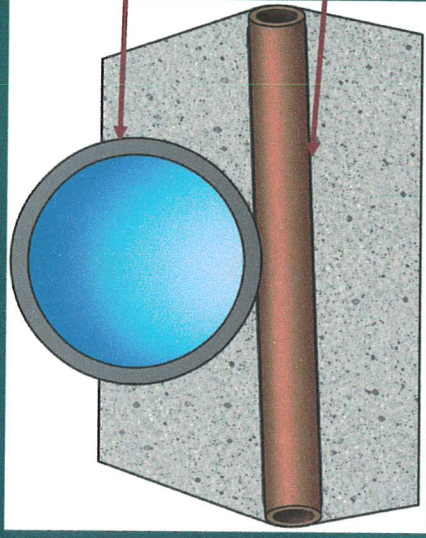
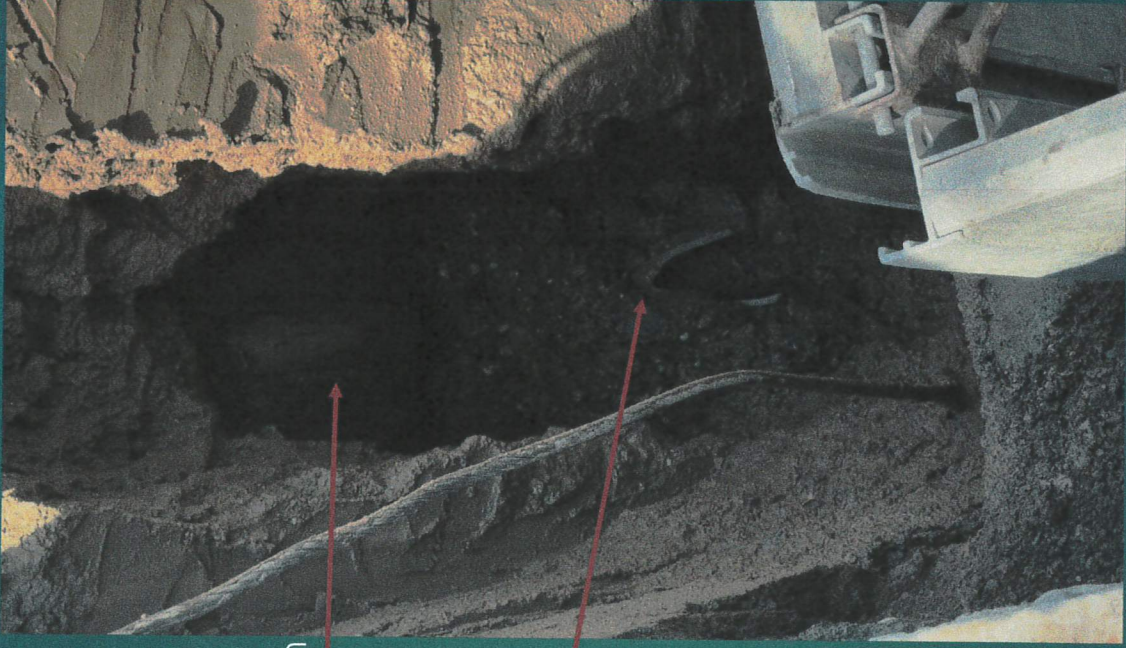
# Excavation Findings

30in Water Main

Sewer Lateral

\*Digital representation cross section (not actual)

Concrete support structure beneath watermain

- ~5ft across
- ~2ft thick
- ~3in Minimum under lateral
- Pipe bursting head unable to pass

\*Measurements are visual estimates not actual

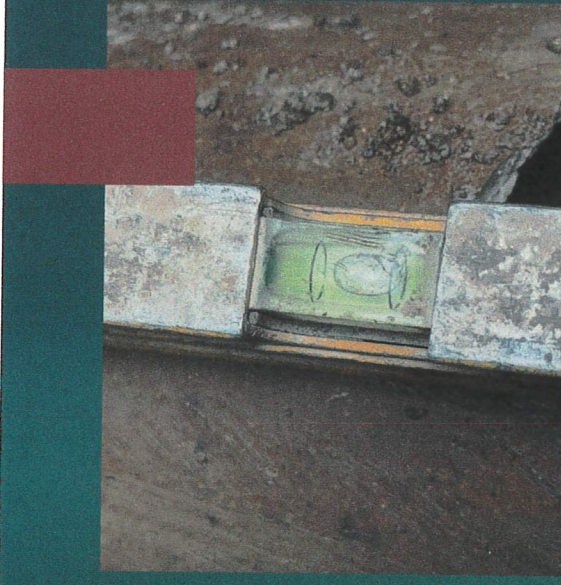
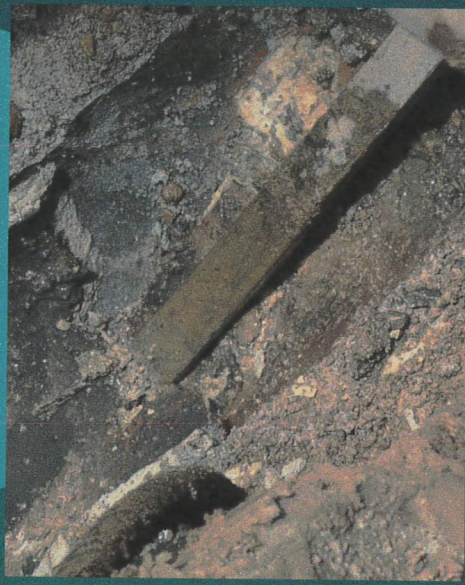
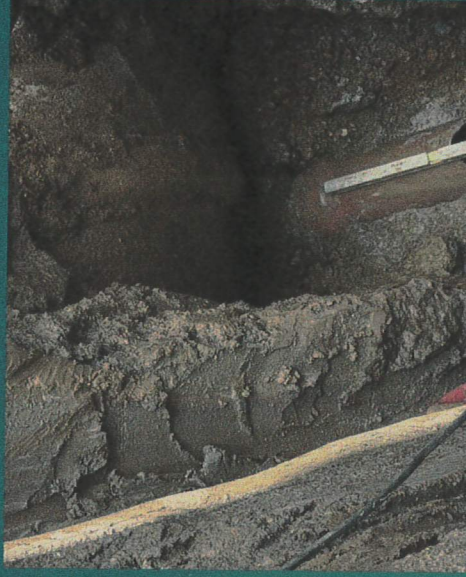
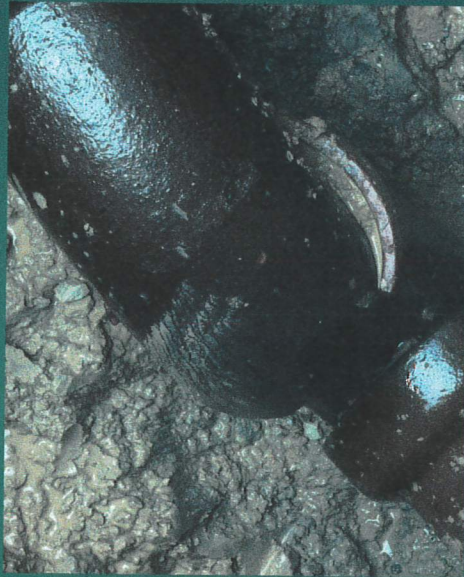
# Additional Findings

- ▲ Sewer Lateral fully encased in concrete beneath 30in water main
- ▲ 30in water main sitting directly on sewer lateral (direct contact) on north side.
- ▲ Sewer Lateral section in concrete is back pitched under water main
  - ▲ Section found to be holding water
- ▲ Lateral missing clay fitting under water main
- ▲ Rocks directly against clay sewer lateral by water main
  - ▲ Original blockage consisted of rocks
- ▲ Clay double 90s at end of sewer lateral run
  - ▲ Supported by bricks

1. Pipe bursting was the appropriate repair method based on known site conditions and MMSD pipe check program
2. Under the 30in watermain the Sewer lateral was fully encased in concrete including an observable ~2-3 in or more of concrete beneath the lateral
3. The 30in watermain was making direct contact with the sewer lateral on the north side
4. Pipe bursting was prevented solely by the concrete encasement and 30in water main.
5. Additional excavation was necessary solely due to the encasement
6. Additional costs of \$16,900 above original proposal resulted directly from the concrete encasement and associated road restoration requirements.

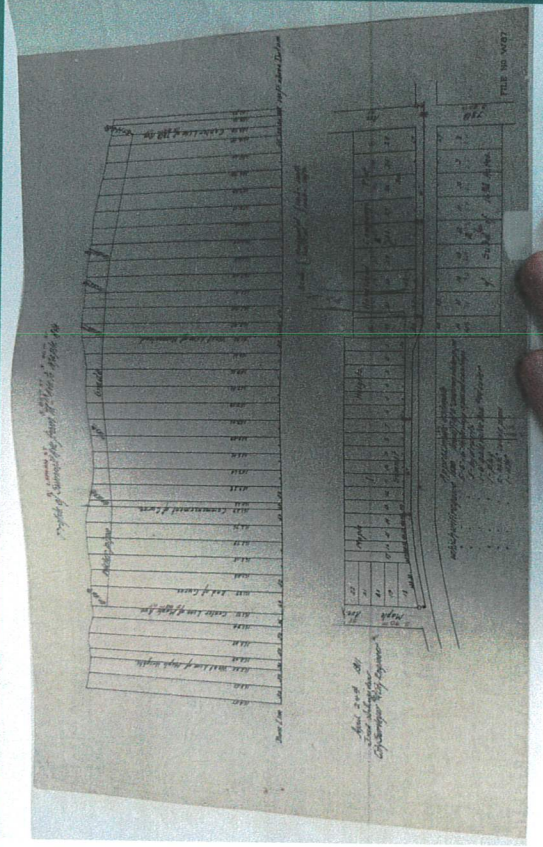
As-built for section of street one block over, does not show my plot

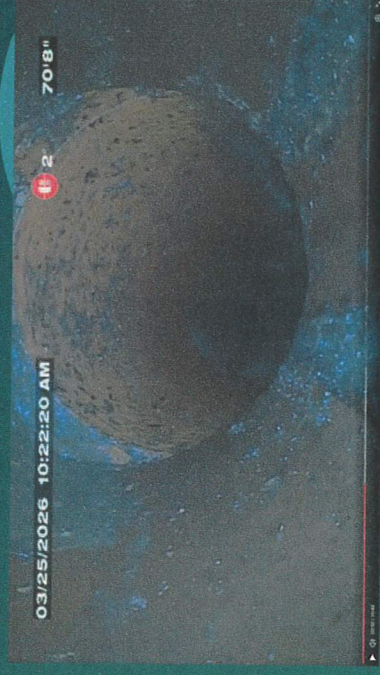
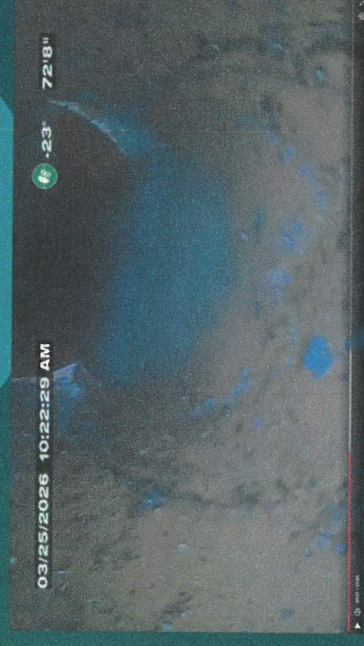
# Sewer Camera Footage Images & timestamps Pt 1

[Link-02:52](#) – Start of First off set at ~71ft from  
clean out

[Link-03:01](#) – Water and debris reaccumulating  
immediately after Vacuuming out lateral in  
back pitched pipe at ~ 73ft from clean out

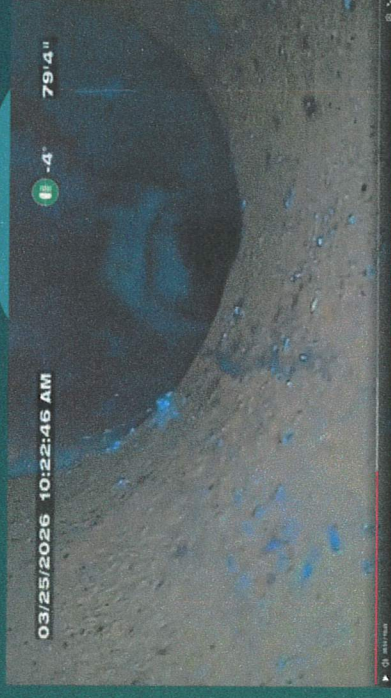
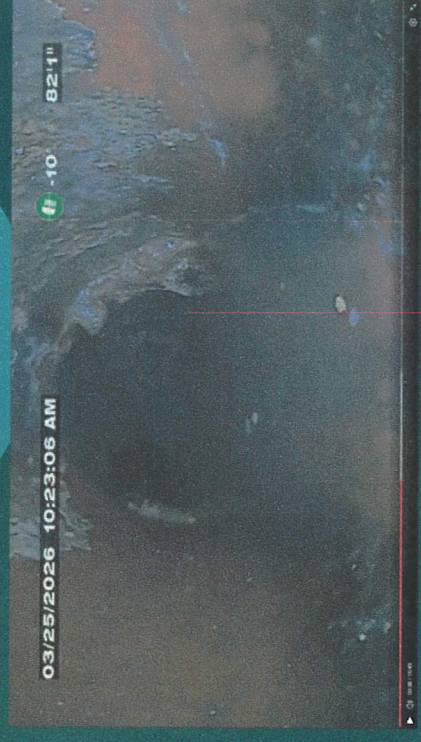
# Sewer Camera Footage Images & timestamps pt 2

[Link- 03:19](#) – Second off set at ~80 ft from clean out

[Link- 03:38](#) – end of second off set and start of double 90's at ~84 ft from clean out

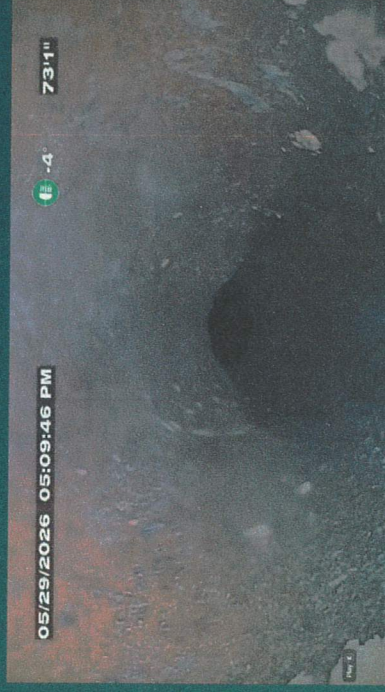
Figure E-1. Sewer camera still showing standing water and rock material at approximately 73 feet following vacuuming.

**After the sewer lateral was vacuumed clean, standing water and rock material again accumulated at the first offset at approximately 73 feet, despite no additional solids being introduced into the sewer lateral.**

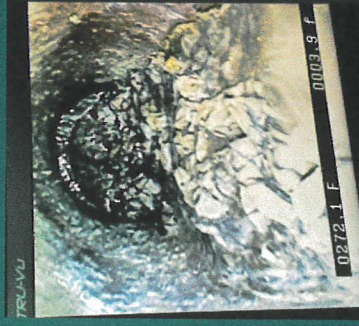
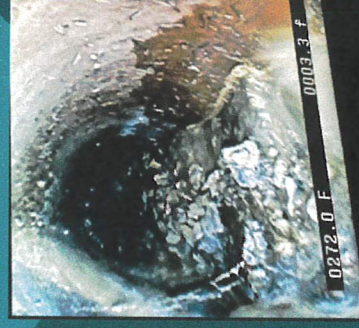
## Citys Lateral Launch Images

**After the downstream portion of the sewer lateral had been excavated and removed, the first offset at approximately 73 feet continued to retain standing water and rock material,** indicating that the hydraulic restriction remained upstream of the sewer main connection.

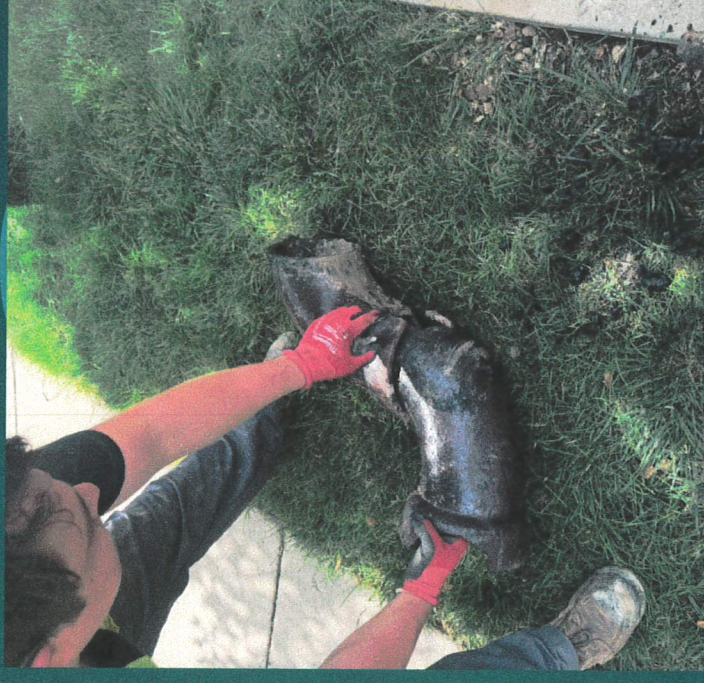
## Day 1

[Link- Excavation of the Connection to the Main & Double 90](#)

[Link- Connection to the Main Post Cleanup](#)

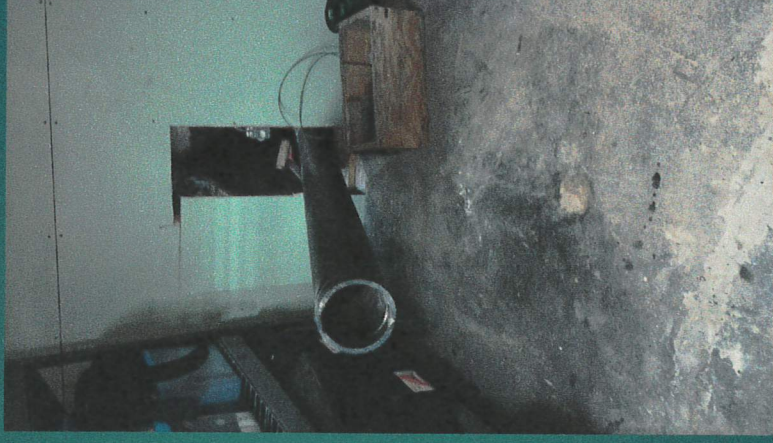
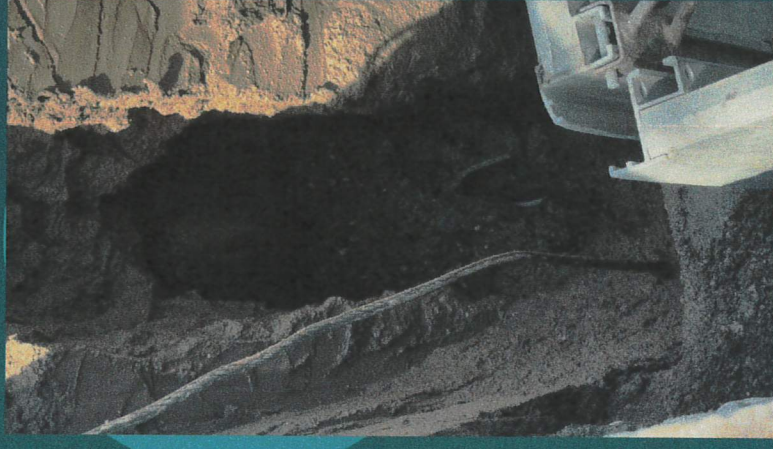
## Day 2

[Link- Lateral in Concrete Under 30in Water Main](#)

[Link- Lateral in Concrete Pt 2](#)

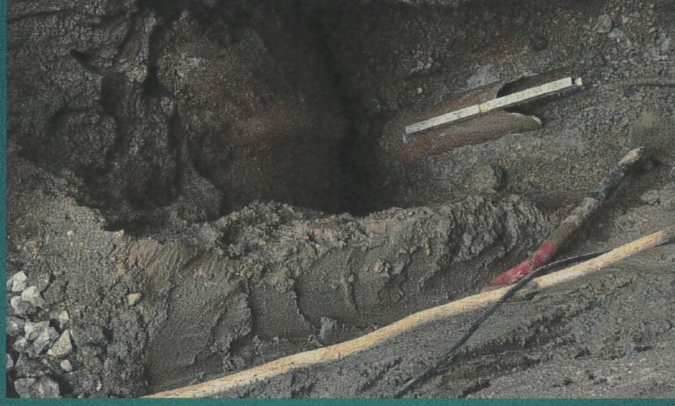
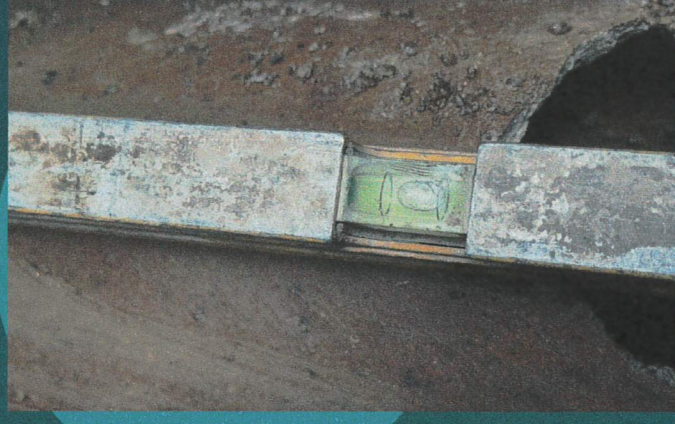
## Day 3

[Link- South Side Watermain, Back Pitch](#)

[Link- South Side Watermain, Concrete Under Lateral](#)

[Link- North Side Watermain, Concrete Extent](#)

[Link- North Side Watermain, NO fitting & Elevation](#)
