# Sewer lateral Investigation

Failure of Private Sewer Lateral Following 1958 Water Main Installation

ADDRESS: 8606 W LAPHAM ST WEST ALLIS, WI

DATE: 04 JULY 2026

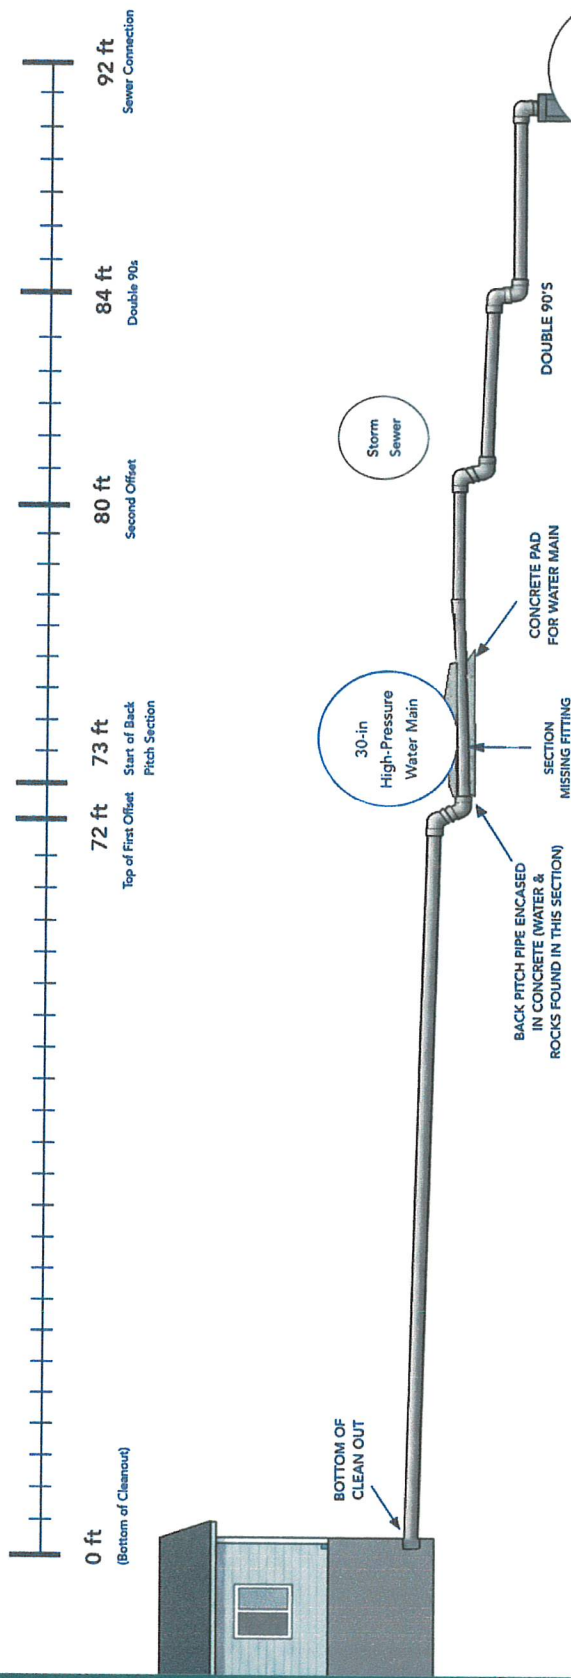
Digital rendering of existing utilities and critical measurements (not to scale).

Note: Measurements are based off sewer camera footage and field measurements. (see appendix)

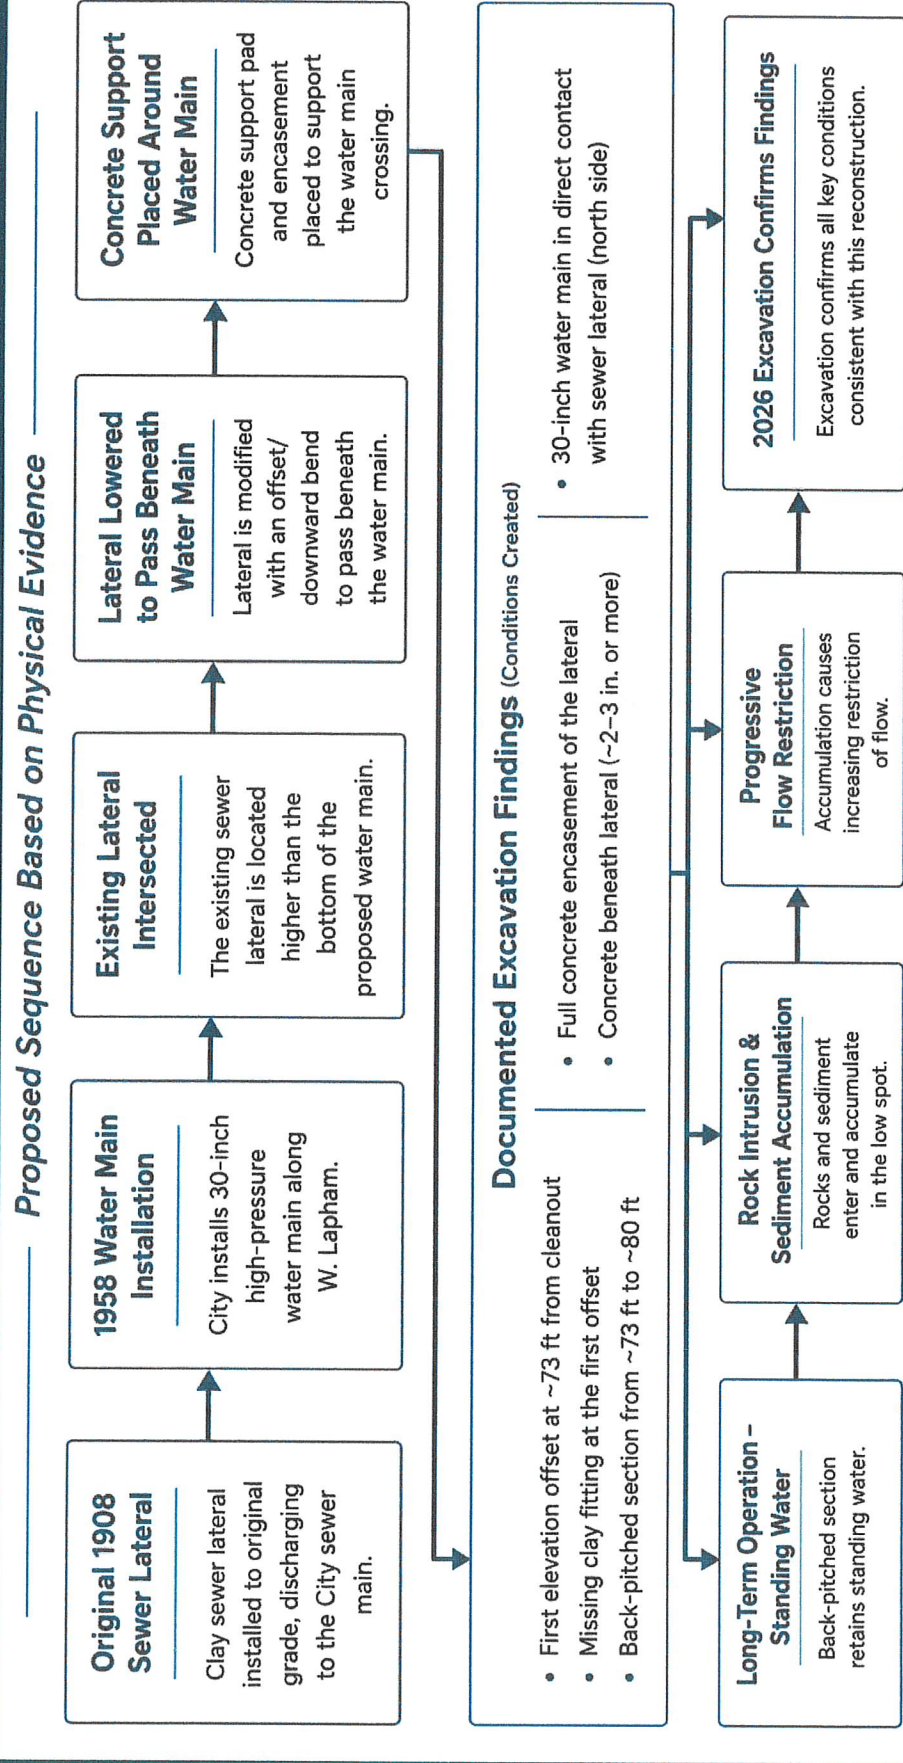
## ENGINEERING RECONSTRUCTION OF OBSERVED CONDITIONS

Every major documented defect—including the elevation offset, missing clay fitting, back-pitched section, standing water, rock accumulation, concrete beneath the sewer lateral, and full concrete encasement—occurred at or immediately adjacent to the crossing beneath the City's 30-inch water main.

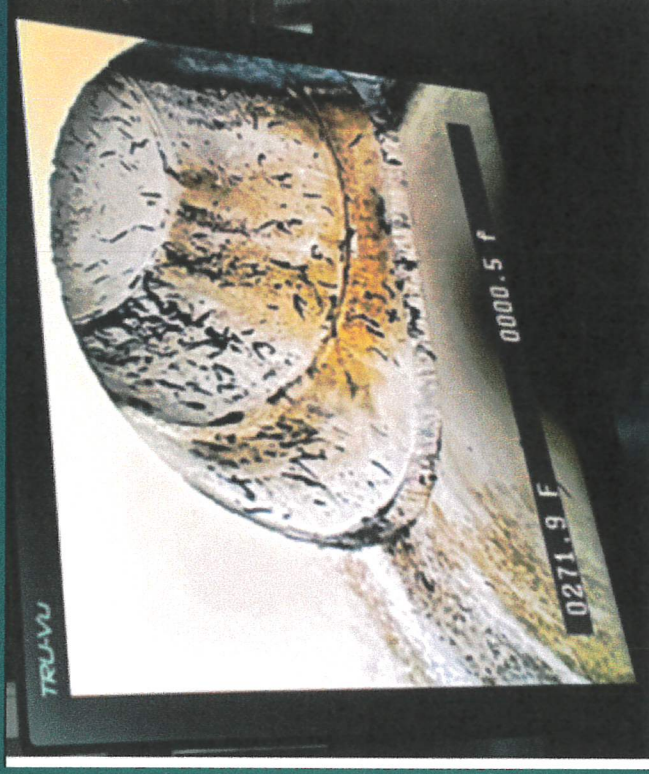
- ✓ The City's assessment identified **soil and gravel entering through a defect further upstream.**
- ✓ Subsequent excavation later identified the first offset beneath the 30-inch water main as the location where gravel repeatedly infiltrated and accumulated.
- ✓ Contractor observations documented gravel in direct contact with the sewer lateral at that same location.
- ✓ **The excavation findings under the 30in watermain independently corroborate the City's original engineering assessment.**

As shown in figures 2 and 3, a large amount of gravel and small stones have blocked the clay lateral, which is why you've been experiencing the backup. **This is most likely due to a break in the clay pipe further upstream, and the surrounding soil has been pulled into your pipe.**

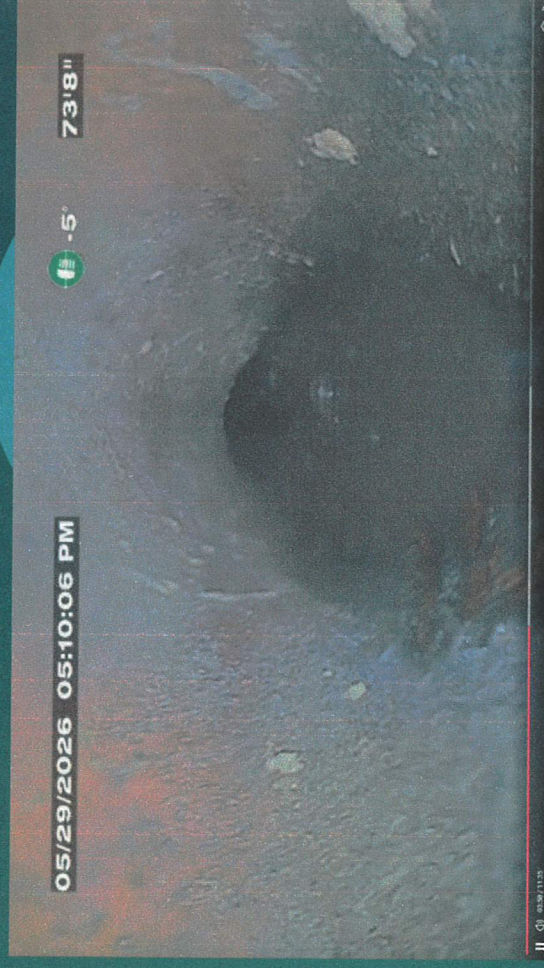
### [Link – Post Day 1 Excavation. Last 10ft of Pipe Removed](#)

Camera inspection following vacuum removal of debris and removal of the downstream 10 feet of sewer lateral. Persistent blockage remained at the first offset.

**After the downstream portion of the sewer lateral had been excavated and removed, the first offset at approximately 73 feet continued to retain standing water and rock material,** indicating that the hydraulic restriction remained upstream of the sewer main connection.

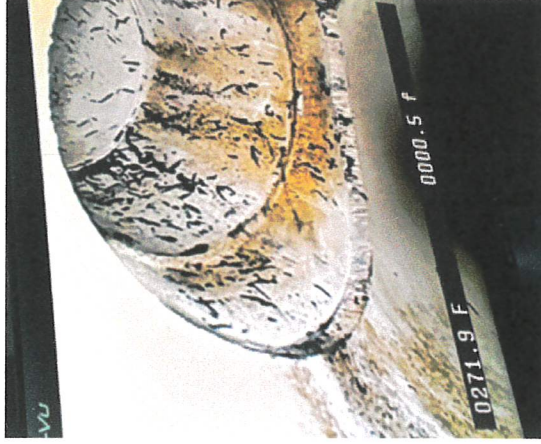
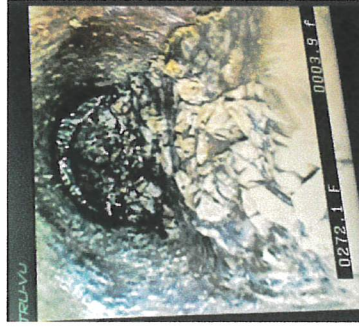
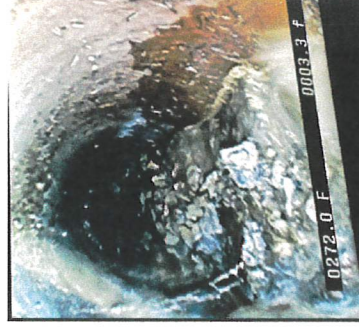
## Citys Lateral Launch Images

| PHYSICAL OBSERVATION | | SUPPORTS RECONSTRUCTION<br>HYPOTHESIS? | SUPPORTS FAILURE<br>MECHANISM? |
|---|---|---|---|
| 9 | <p><b>Independent rock correlation</b><br/>Rocks were documented in the City's lateral launch footage, also observed in the bottom of the offset at ~73 ft, and found in direct contact with the sewer lateral (seen during excavation).</p> | ✓ | ✓ |

7. Excavation later confirmed **gravel, consistent with that observed in the City's lateral launch images, in direct contact with the sewer lateral** at the first offset beneath the 30-inch water main.

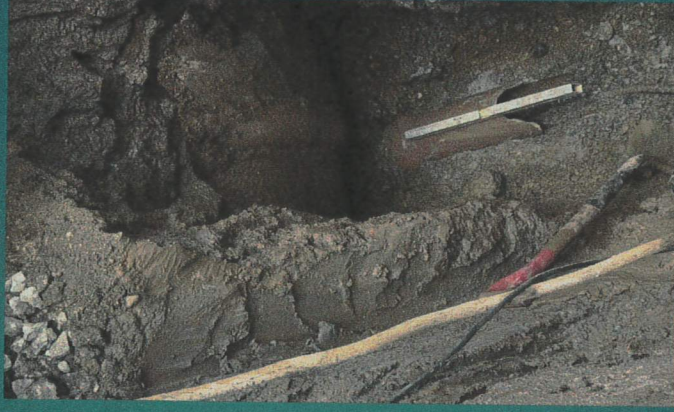
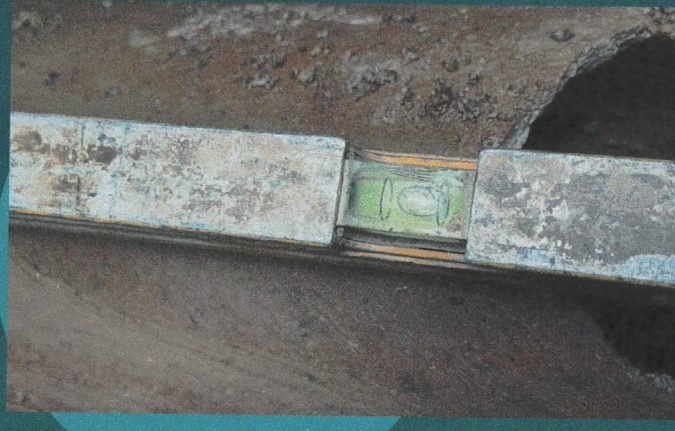
## Day 3

[Link- South Side Watermain, Back Pitch](#)
