February 11, 2009

RE: Reconstruction North/South Alley between S. 59 St., S. 60 St., W. Mobile St. & W. Grant St.

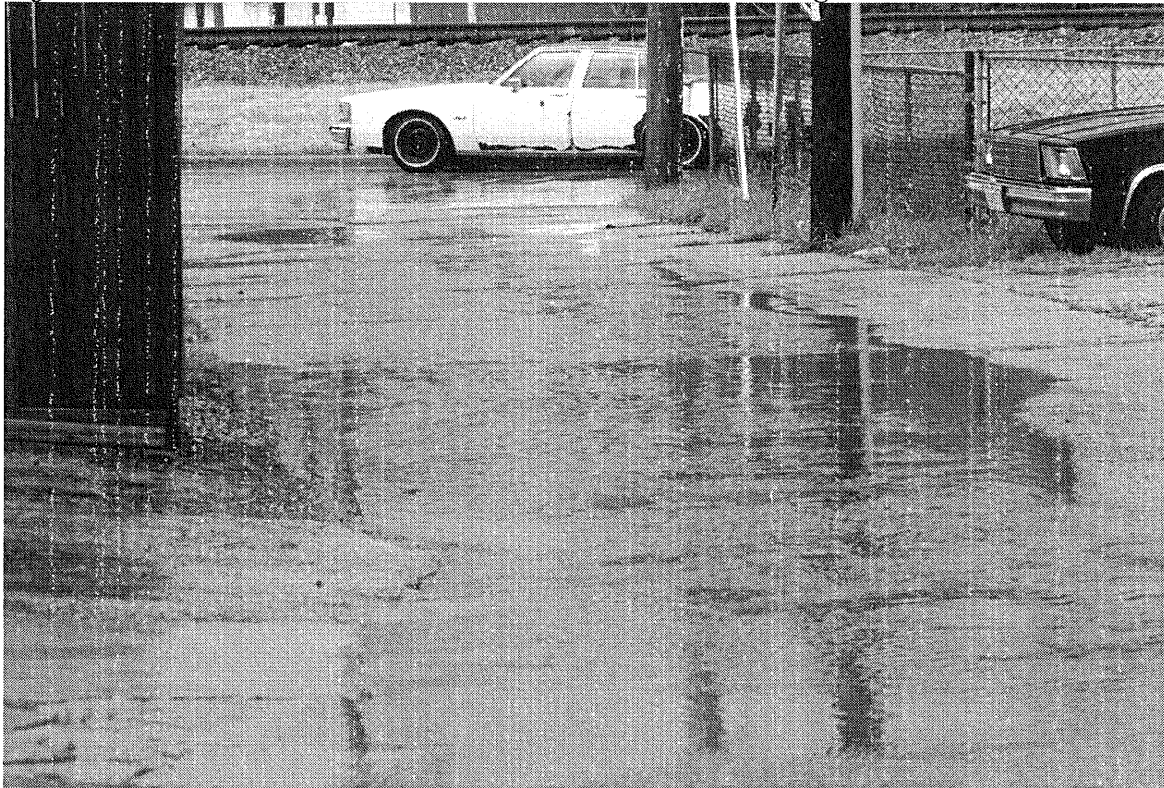
Fig. 1.

The "ponding" at the north end (the end with the catch basin) has become so bad that we are repeatedly having water back up into our garage.

The water no longer drains into the catch basin, but trickles to one side of it, over the sidewalk and into Mobile St. Attached are photos showing the significant ponding after a small rainfall – not the "Great Flood of 2008".

Looking north to W. Mobile St.

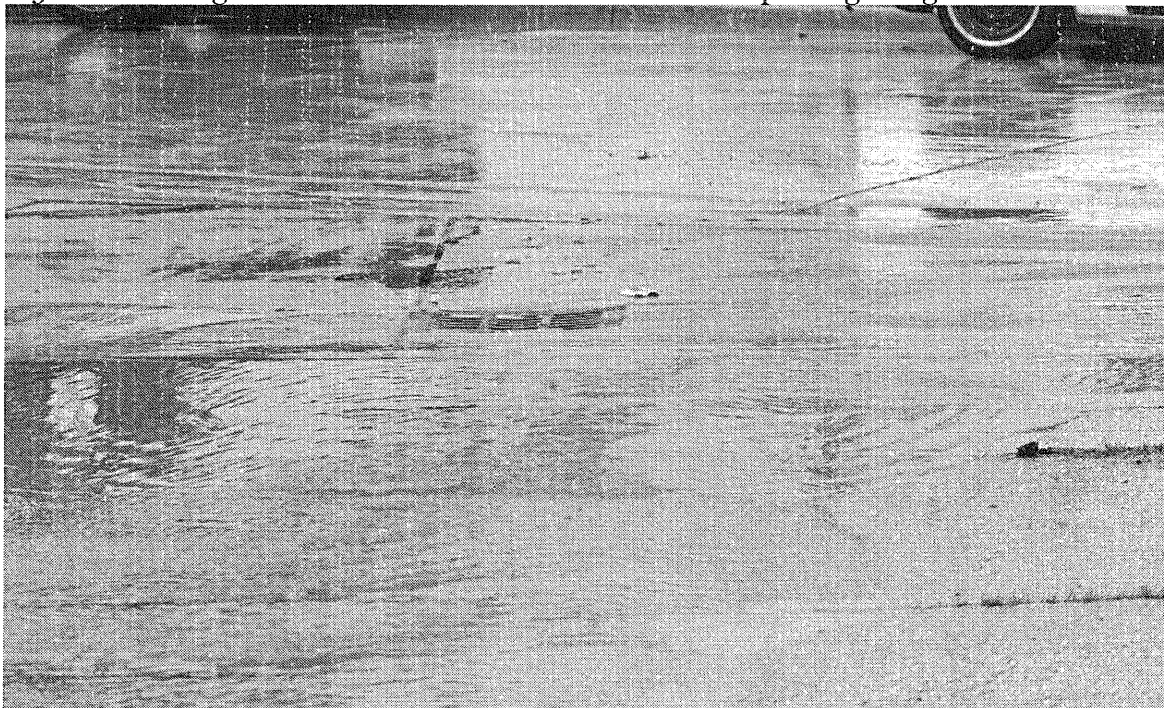
Fig. 2. Looking north toward W. Mobile St. Note water passing to right of catch basin.
