MEMORANDUM

2408 S 67th Street

Sanitary Lateral Repair in street

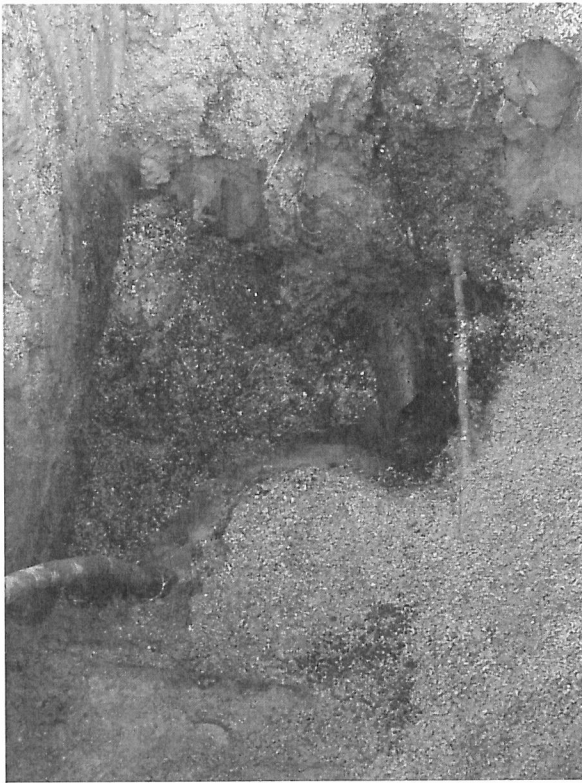
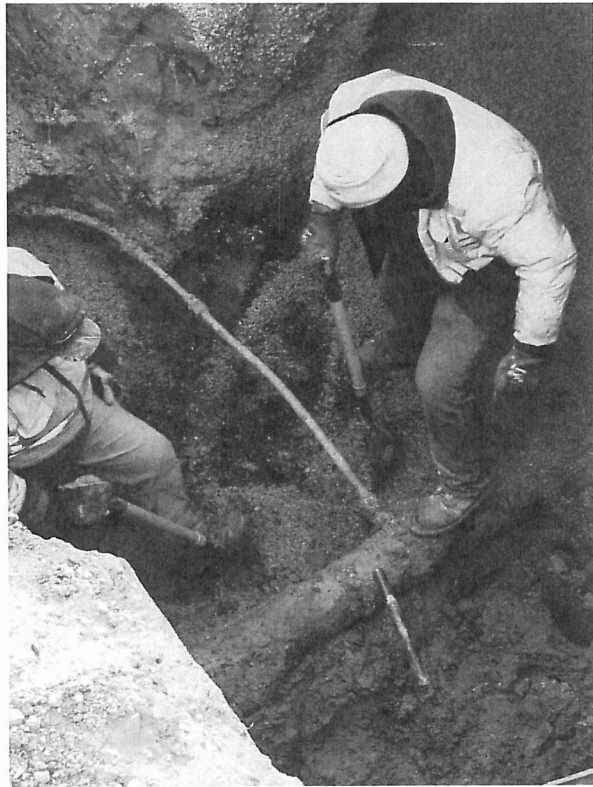
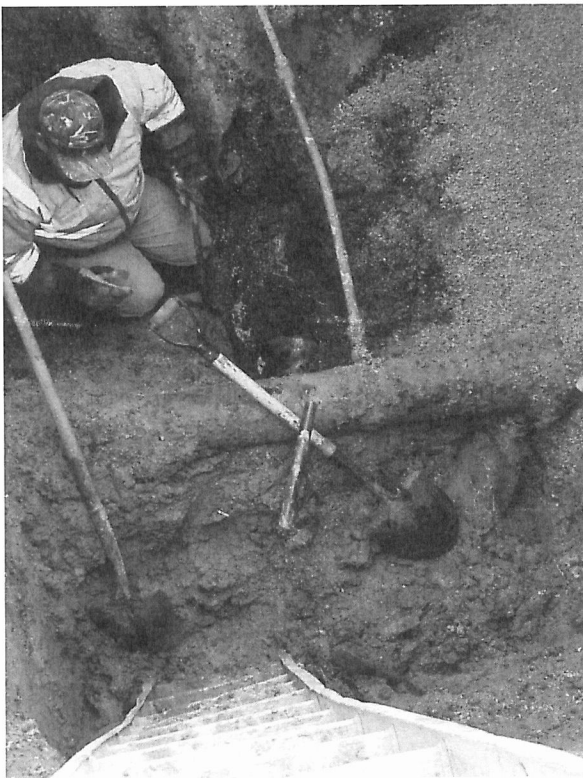
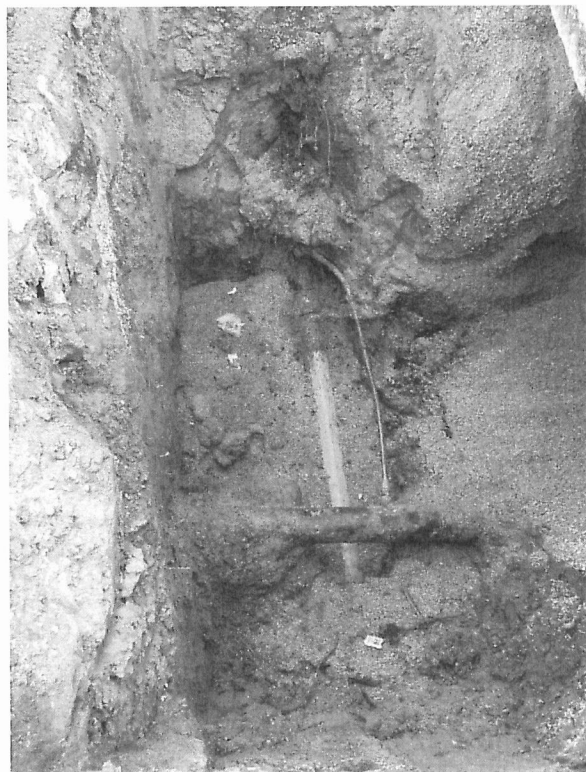
Excavation resumes with back hoe & hand digging around utilities. Once more of the sanitary lateral was exposed, I observed the lateral had failed from the top of the 6" clay pipe. The top of the clay had caved in, allowing for infiltration of 5/8" lannon stone chips into the existing sanitary lateral to the west and thus, eventually causing the blockage. These stone chips were used for backfilling a previous excavation adjacent to the sanitary collapse for a water main break month's earlier (see NOTE). The broken pipe was removed to the nearest joint connection easterly. In addition, a 4' section of existing clay to the west (under water main) was removed because of exposed roots at that joint. Altogether, 72" of 8" PVC was used to repair the lateral to City standards.

The City of West Allis Water Division performed an emergency repair to the broken 6" cast iron water main on July 12th of 2018. The water main break was located approximately 4'–5' (feet) south of existing sanitary lateral. A repair sleeve was placed on the water main and a new service was tapped just north of where the previous service was, according to Mike Brofka. The Water Department placed a new corporation valve & approx. 5' of 1" copper pipe, connecting water service to the same address as above. The new location of the service at the water main is approximately 1' south of the existing broken sanitary lateral. The sleeve portion was never uncovered during the sanitary lateral repair. Also note, the sanitary lateral is running in a direction downward from the home and underneath the water main. I am unsure if the sanitary lateral was ever uncovered during the emergency water repair. The proximity of the excavation to the sanitary lateral was extremely close; hence the 5/8" chips in the lateral.

I recommend the water department investigate further and initiate reimbursement as they see fit.
