## **MEMORANDUM**

## 2034 S 93rd Street

Sanitary Lateral Repair in street

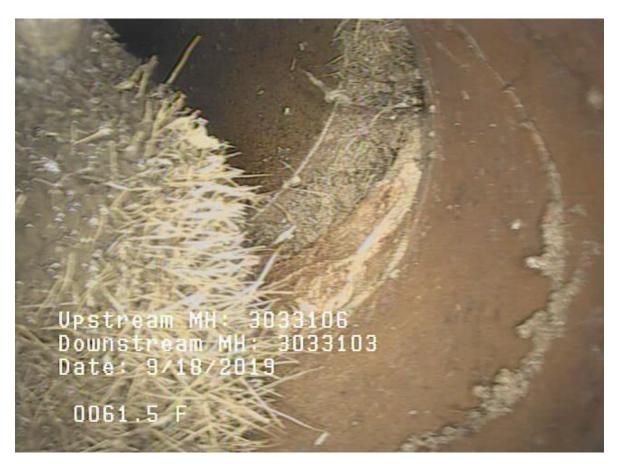
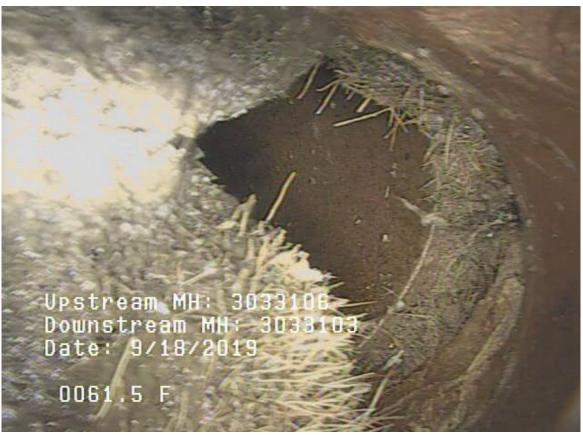
Photos of connection at city sanitary sewer main

Upon review of the 2019 video televising, it can be seen that connection was in need of repair (photos attached on 2<sup>nd</sup> page). I would have scheduled this lateral connection to be repaired by a "T-liner" and if that didn't work, it would have had to be dug via a spot repair.

Due to the poor condition of the sanitary lateral connection at the city main and the fact they had to repair a portion of our city sanitary sewer – I would recommend Robb Fallon be reimbursed the 50% of his repair bill that he paid to Rozga. This total would be \$5,404.50 and could come out of the appropriate sanitary sewer utility account.

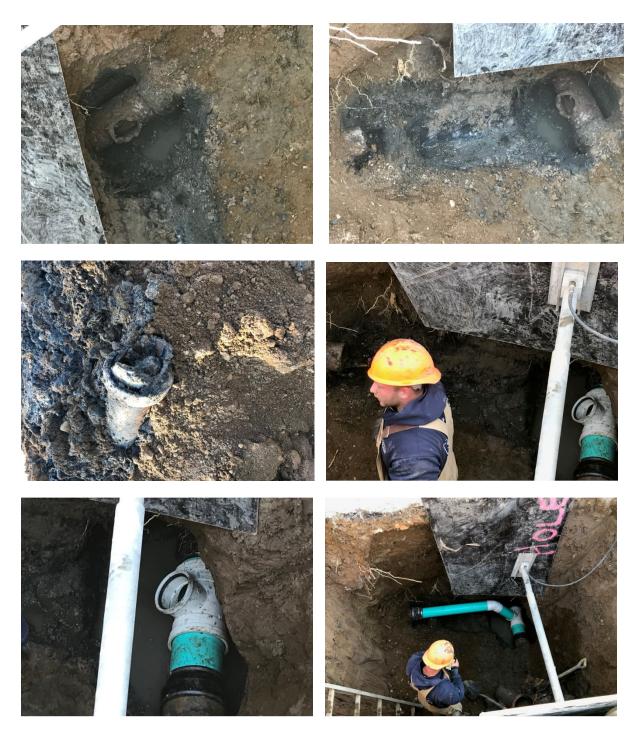
I have not seen televising from the house towards the main that would show condition of the entire lateral. However, based on the construction pictures that were submitted on Greg's Memo, the darkened soil indicates there were additional issues further upstream of the connection point at the city main.

Rozga Plumbing & Heating Corporation applies for permit on 12-17-19 and repairs failing 6" clay lateral and small portion of 8" clay main with a tee-connection on 12-19-19. (3 man crew).

Due to the location of the repair and the fact that the plumber removed portions of the lateral prior to inspector being on-site, I cannot 100% identify where the actual failing lateral occurred.
